Spillage from a semi-buried jet fuel tank

December 30, 2005

Sainte-Marie – [Reunion Island]

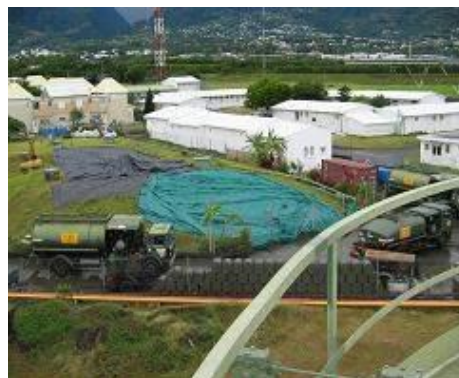
The quantity of jet fuel spilled was estimated at 33 m³. The product spilled onto the surface covering the underground tank and seeped into the ground, outside the bund and into the common parking lot in the zone B. The parking lot is connected to a hydrocarbon separator, which quickly became saturated. Roughly one hundred litres of hydrocarbons thus entered the rainwater drainage system that spills into the sea.

▲ Product infiltration zones ©

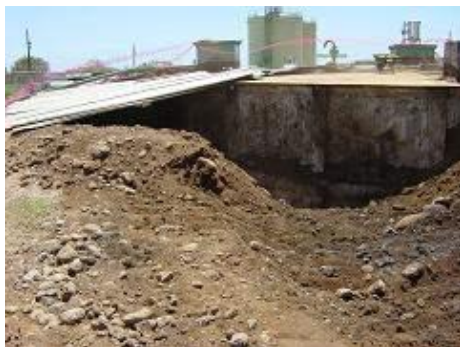
▲ Digging operations round the SEA2 tank ©

Following emergency operations that involved stopping the spillage, containing the fuel, shutting down the drinking water supply well, waste collection and the superficial clean-up of the zone, the initial digging operations were undertaken to remove the highly polluted soil as soon as possible. This required the tank's casing to be uncovered and the tank drained. The soiled earth was stored in bins on the site B prior to cleanup, and an initial review was conducted to determine the environmental impact of the accident. Research projects to install and equip a facility to treat the soil were undertaken.

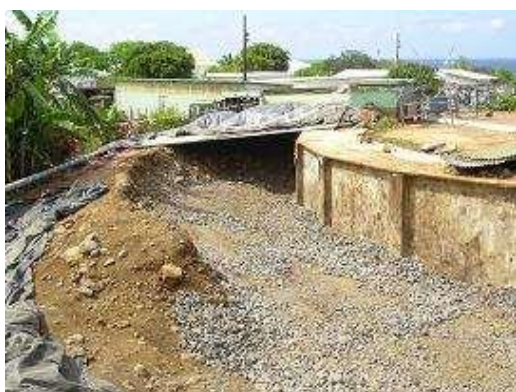
▲ Backfill around tank SEA2 ©

In October 2006, the polluted soil storage bins were removed from the depot B parking lot to a site specially equipped to process the soil. The removal of the earth continued to the polluted zone. Treatment of the polluted soil using bio-venting was started in December 2006. Approximately 1,000 m³ of soil has been removed since the day of the accident.

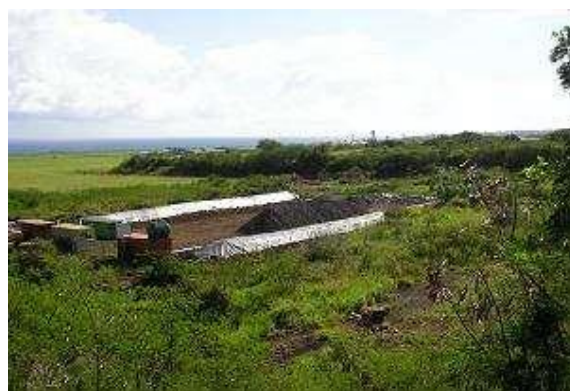
▲ Treatment of polluted soil ©
