Sudden opening of a crude oil tank bottom

January 12, 2007

Ambès [Gironde]

France

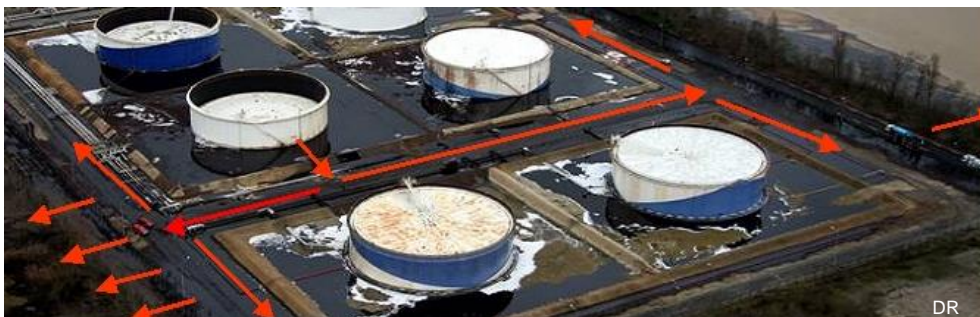
On January 12, 2007 at 8:00 am, a portion of the tank bottom broke and 12,000 m³ of crude oil spilled in a matter of a few seconds.

The earthen dykes were able to mechanically withstand the wave effect. However, 2,000 m³ of crude oil overflowed and spread on the ground and roads both in the immediate area around the depot and outside the site.

The products that spilled into the gutters and retention basin were channelled towards the site's settling pond and then transferred into empty storage tanks. Approximately 6,000 m³ of product were pumped in this manner.

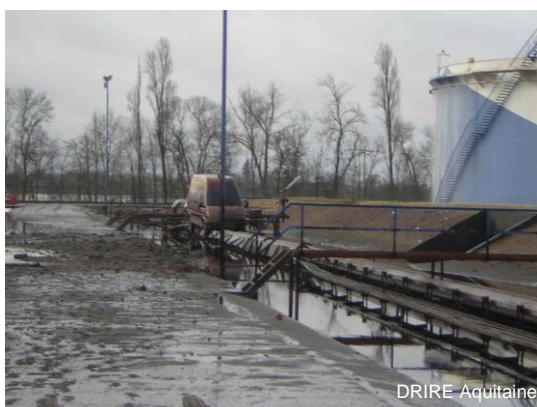
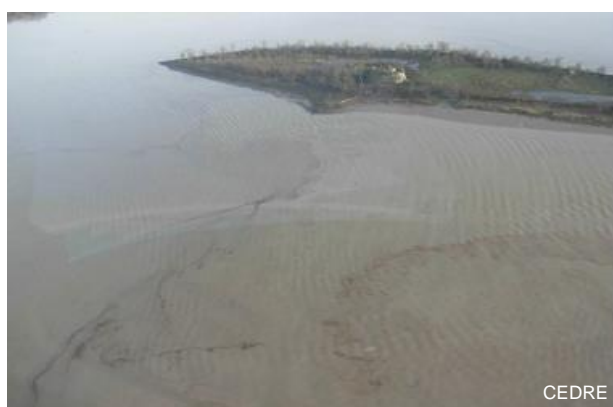
Most of the $2,000 \text{ m}^3$ of oil spilled outside the basins was confined within site boundaries. A substantial percentage of this volume quickly reached the stormwater ditches and then by gravity flowed into the settling pond, thus triggering the immediate shutdown of pumps used for discharging pond water into the external environment, although 100 m^3 did get released before pump shutdown:

- 50 m^3 flowed into "jalles" (pits and swampy channels) located to the east of the site, where the oil polluted 2 km of ditches and infiltrated deep enough to reach the water table.
- To the west, another 50 m^3 reached the Garonne River at the beginning of the flood tide period. For the most part, the oil slick remains enclosed along the river's right bank, yet it was rising at the time because of the flood-tide condition. Iridescence could be observed all the way to the *Pont d'Aquitaine* Bridge 12 km upstream. When the tide changed, the oil slick shifted downstream and reached the site of the "*bec d'Ambès*" (confluence of the Garonne and Dordogne Rivers).

To the south, the oil also spread over the ground and small roads, contaminating down to deeper layers, then crossed departmental highway no. 10, at which point it was largely contained by a parapet running parallel with the Garonne. A small quantity nonetheless seeped through and slightly contaminated the upper part of the riverbank at this location.
