## Spill of heavy fuel oil in an oil terminal

21 June, 2003

Oil harbour of Göteborg

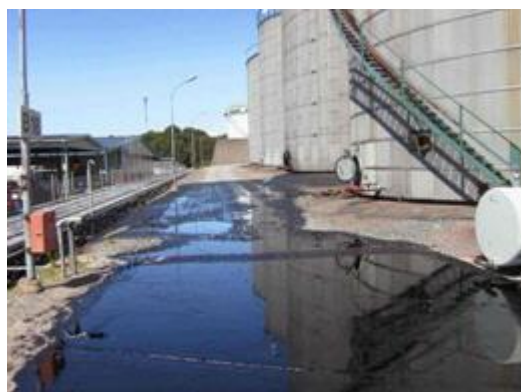
*Oil spill outside tank No 375 was spread on the surrounding ground. Under the pipe rack (in the left) there was a rain water drainage sewer.*

- ✓ The oil terminal is an old installation and therefore there were no bunds around the tank area where the accident occurred. The spilled oil was spread over a wide area on the surrounding ground. In a low point under a pipe rack close to the storage tank there was a rain water drainage sewer. A huge amount of heavy fuel oil reached the harbour rain water drainage system.

- ✓ The sewer under the pipe rack in the oil terminal has been connected to the harbour oil contaminated drainage water system and is no longer connected to the rain water drainage system.
- ✓ Oil alarms have been installed in the rain water drainage basins. In each basin there is now one oil alarm located at the surface and one oil alarm located in the bottom of the basin.
- ✓ Installation of oil alarm in the rain water drainage system at each oil terminal has been started.
- ✓ Installation of shut off valve of the rain water system at each oil terminal has been started.

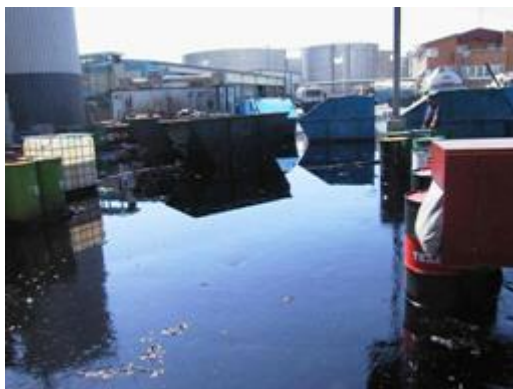
*The ground at a neighbour company was filled with oil.  
Photo: the insurance company.*

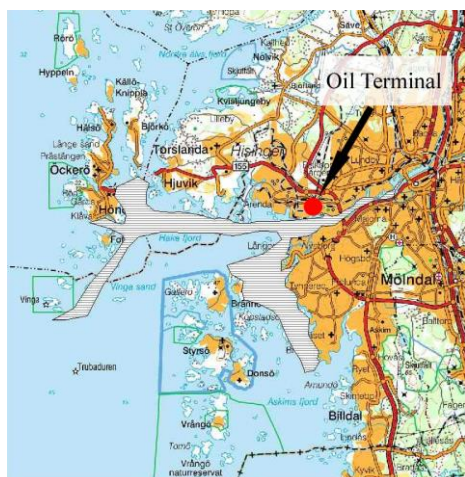
The area outlined on the map shows how the oil was spread in the coast archipelago outside Göteborg. The oil spread in two main directions, south and west from the harbour of Göteborg.

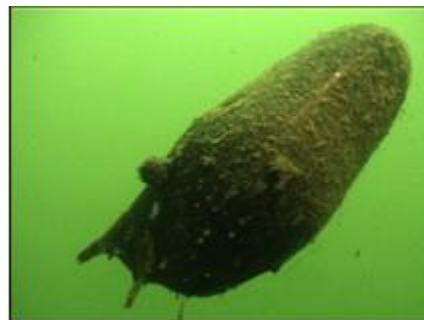
- ✓ The heavy fuel oil was probably mixed with lighter high aromatic oil and therefore the oil did not behave as expected. This heavy fuel oil formed clusters in the water and were spread over a wide area in the coast archipelago. The clusters dispersed and oil were detected on the sea water surface and on several beaches and harbours outside of Göteborg.

*The oil formed clusters that did not float on the water.  
The diameter of the clusters was 3 to 10 centimetres.  
Photo: Swedish Coast Guard.*

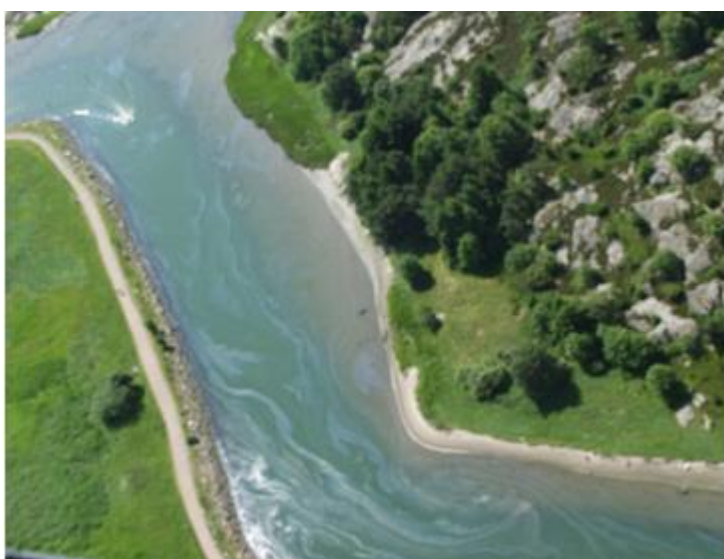
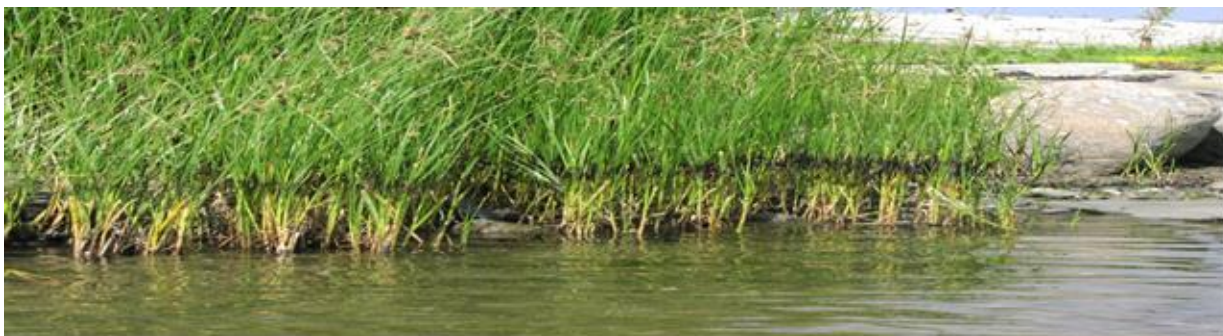
*Environmental consequences of the spill of heavy fuel oil in the oil harbour.*
