Explosion of a superheater within a steam-cracking unit

15 July 2009

Saint-Avoid (Moselle)

Petrochemical industry
Gas explosion
Ignition/start-up
Instructions
Automatism/regulation

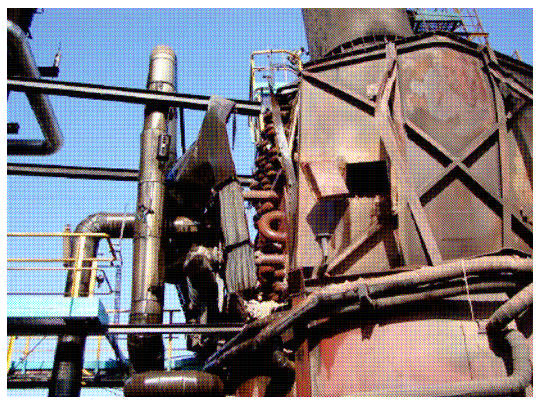
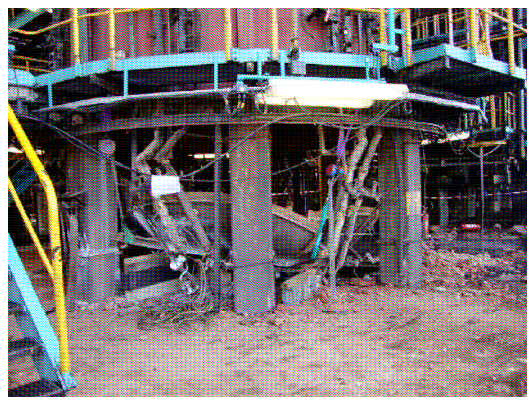
Property damage was confined to the superheater and its immediate vicinity (Fig. 4).

Figure 4 : View of damage sustained on the upper part of the superheater and collapse of the floor plate (DREAL Lorraine)

- an accumulation of inflammable gas, yet within the flammability limit: the operator's investigation pointed to the hypothesis of a gas flow surge in the direction of a burner during the start-up phase as the ignition step was being carried out ;
- ignition of the cloud by either the tube ignitor or a hot spot inside the superheater convection zone. Other ignition sources could also be envisaged (e.g. electric spark, static electricity), yet these two cited sources would seem the most plausible.

- failure to steam-sweep the superheater prior to its re-ignition, as stipulated in the operating procedure issued by the plant management ;
- gas input via a burner, despite the flame on the associated pilot being extinguished ;
- the technical safety system, which prevented supplying burners with gas in the absence of a pilot flame, was not operational. This system was composed of an automated mechanism that closed the gas supply valves in the event the flame detector was not triggered following a 10-second time delay. This mechanism would have been bypassed due to its perceived lack of reliability within the specific environment of this superheater. Such a reliability loss could have caused the superheaters to behave erratically and led to repeated shutdowns/start-ups of the

This accident led the site operator to completely modify the ignition sequence of a superheater in order to limit the risk of repeating such an accident, in terms of both probability of occurrence and consequences; these efforts consisted of :

- introducing a programmable and servo-controlled automaton requiring all start-up stages to be performed, namely :
 - o steam sweeping ;
 - o pilot ignition ;
 - o burner ignition.
- setting up a control chart that comprises, among other things, the pilot lighting sequence and the procedure for remote-controlled valves. This measure made it possible for personnel to initiate the superheater ignition sequence remotely, thus limiting their exposure in the event of explosion.
