Fire on a stainless steel production line

23 December 2012

Gueugnon (Saône-et-Loire)

Metallurgical industry
Fire
Stripping
Fire detection
Fire extinguishing
Lockout
Maintenance
Hot spot
Backup power supply

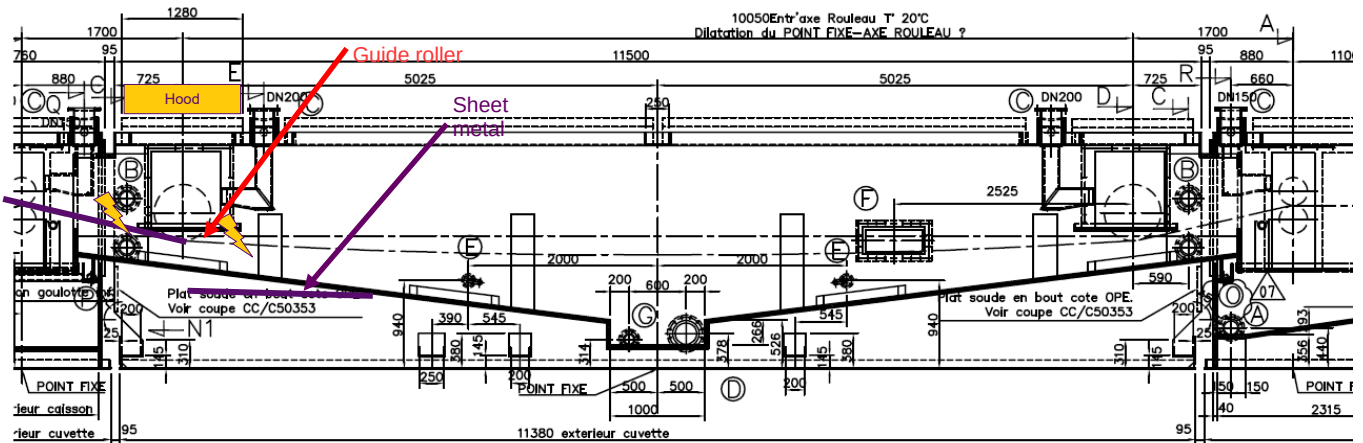
Less customary however was the fact that this operation had been carried out using a sheet metal strip guide roller, in a particularly narrow spot, which required the operator to wear both a head lamp and a mask.

The tests performed by the plant operator revealed that the material surrounding the roller, i.e. EPDM (ethylene propylene diene monomer) rubber, only required a small amount of energy to ignite. Placing a match in immediate proximity would cause it to slowly burn and be consumed entirely.

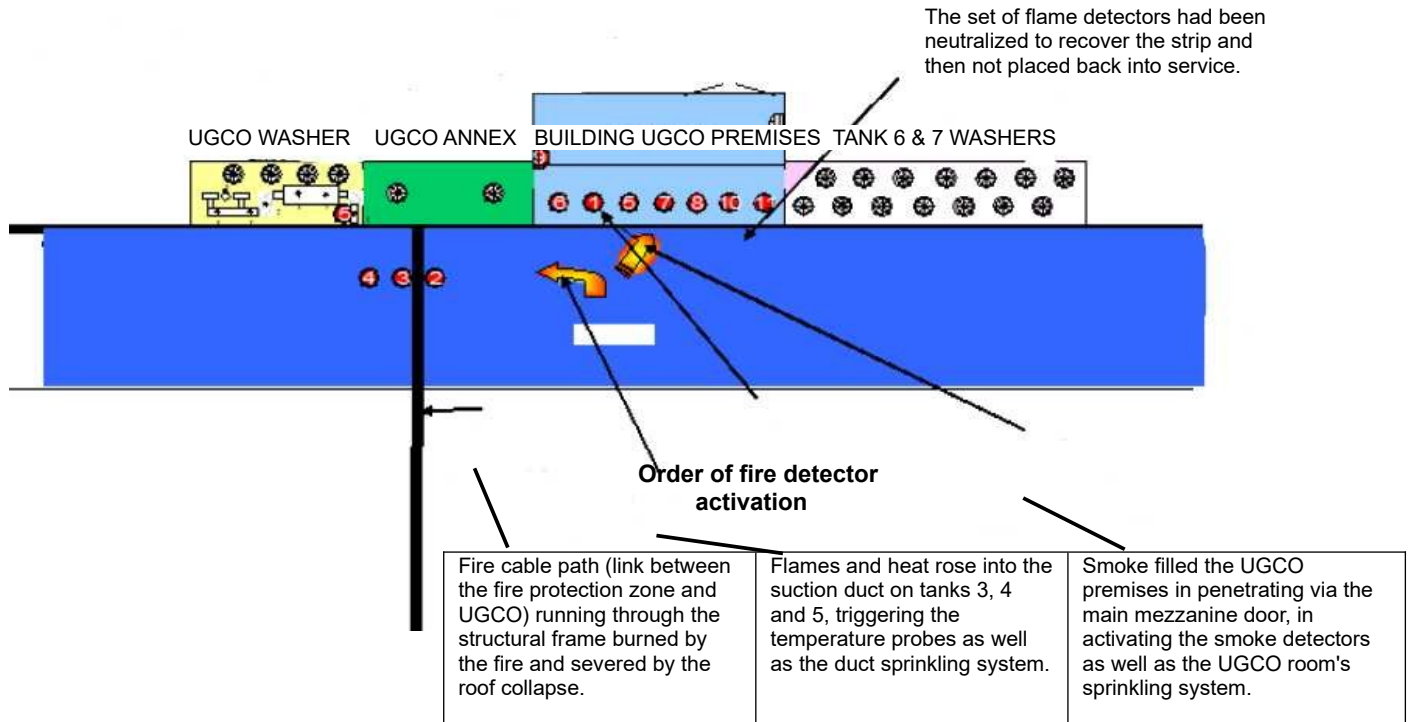
Diagram depicting the chronological order of fire detection activation (source: operator)

1 - P73 smoke detector on the mezzanine level of the UGCO premises - fire-fighter's beeper alarm.

2-3-4-5 - UGCO duct temperature probes - sprinkler activation in the ducts of tanks 3, 4 and 5.

6 through 11 - smoke detectors on the mezzanine level and on the UGCO premises - sprinkler activation after melting of the sprinkler head on the mezzanine level.

Cut-off of the connection between the fire protection zone and the stripping detection after destruction of the cable path through the structural frame.

Manual tripping of the sprinkler system in the structural frame of tanks 3, 4 and 5, followed by roof collapse, causing the sprinkler network to fall.

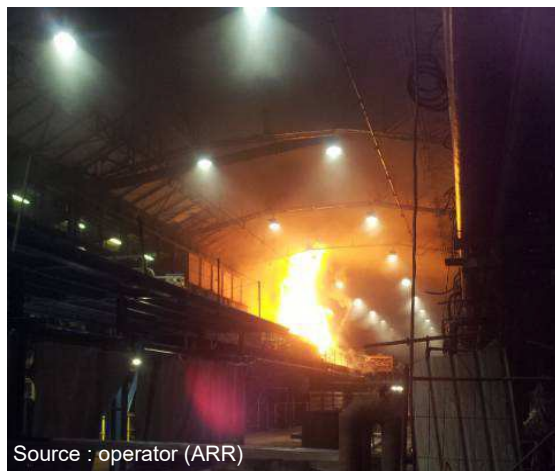
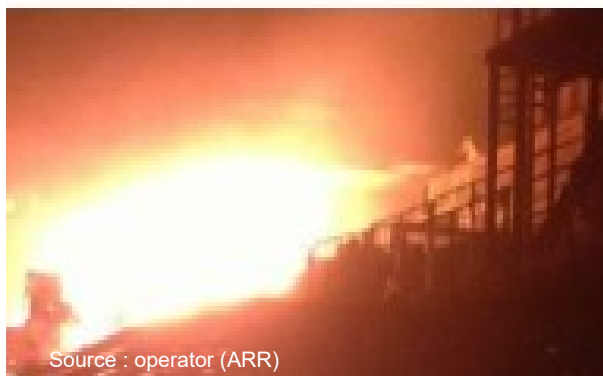
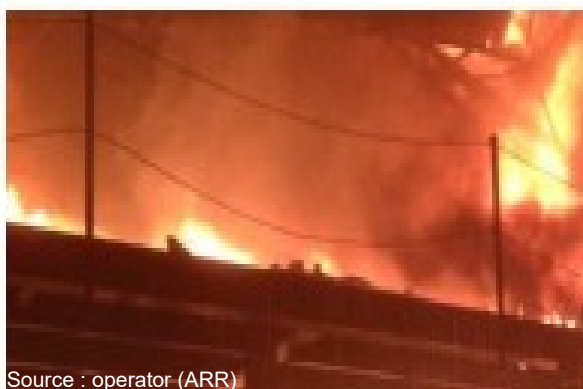
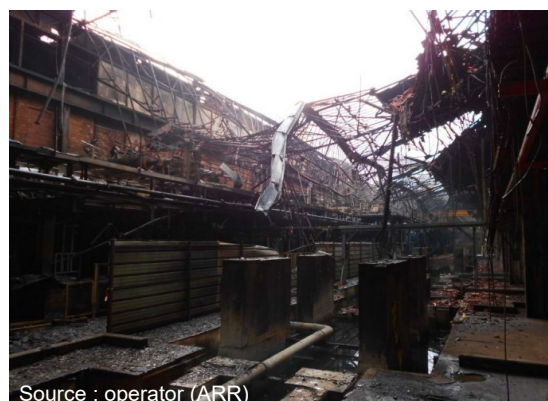
The main physical consequences of this outbreak were:

- complete destruction of tanks 3 through 7 and their supporting structures;
- complete destruction of the recycling basins on tanks 6 and 7;
- destruction of the vapour extraction systems on tanks 3, 4 and 5 (UGCO washer);
- destruction of the building over a 120 m length;
- partial damage of the asbestos cement roof located on the eastern lean-to of building 37;
- damage to overhead travelling crane 114.
