Extended release of mercaptan at a chemical plant

21 January 2013

Rouen (Haute Normandie)
France

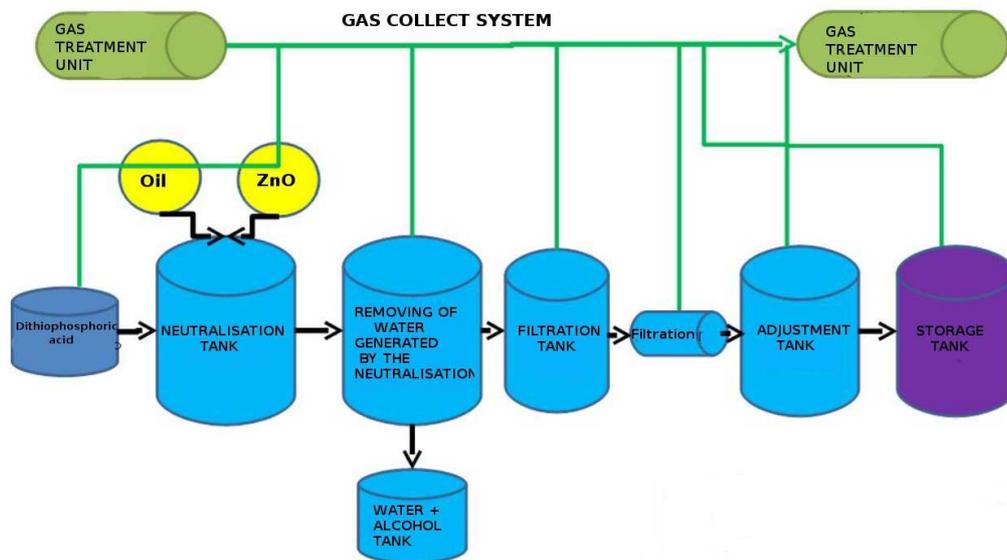
Fig. 3: Final part of the ZDDP synthesis process (DREAL Agency, Haute-Normandie)

The complex compound obtained is then dissolved in a hydrocarbon (oil on the diagram), separated from the aqueous phase by stripping (neutralisation on the diagram) and filtered before altering its composition by adding hydrocarbons. This adjustment step is carried out in the 30-m³ capacity T76 tank equipped with a product recirculation line that contains a manual pump and sampling device. Reaction stability of the sample is controlled on-site by the technician responsible for extraction. The product's commercial compliance is then verified in the plant's laboratory. In case of noncompliant specifications, the product is once again pumped into the filtration process for a repeat filtration. The compliant product is fed to a unit storage tank (T35) prior to commercial distribution (Fig. 3).

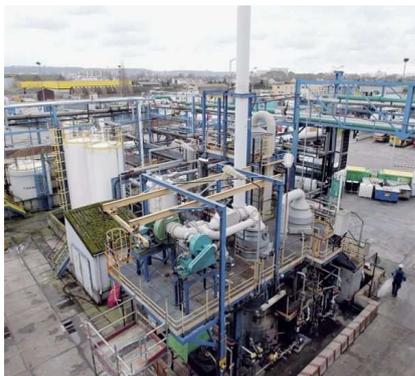
Fig. 4: Gas treatment unit (Paris Normandie)

All storage and mixing equipment vents are connected to a gas collect system (extraction flow rate: 500 m³/h), which channels gases to the gaseous effluent treatment unit (Fig. 4), where 3 columns wash the gases with soda water either on its own or mixed with liquid bleach. One of these columns also served to inject chlorine dioxide (ClO₂) in order to neutralise, by means of oxidation-reduction, the traces of mercaptan released in the event of decomposition at the time of the synthesis step. The unit is fitted with an exhaust stack connected to a continuous analyser (gaseous phase chromatograph along with a sulphur compound detector) used to measure traces of hydrogen sulphide (H₂S, a highly toxic and foul-smelling gas) and mercaptan (a foul-smelling and toxic gas when present in high concentrations) at the release point in addition to detecting any eventual excess of authorised contents for these compounds. Occasional measurements using colorimetric (Dräger type) tubes may be conducted.

- a delay in preparing the 1st neutralising solution on Monday morning subsequent to difficulties encountered in starting up the mobile mixer (due to a missing drive), logically resulting in a poorly mixed solution;
- performance of the gas treatment system which, despite being well designed to treat the H₂S released quickly became saturated once mercaptan emissions rose to high levels.¹⁰

Focused on the risk of toxic H₂S emissions, the unit's analysis also paid insufficient attention to the risk of a massive mercaptan release. The gas treatment system had only been designed for low mercaptan emissions, and the emission measurement chain at the stack outlet had only been calibrated to measure trace amounts of mercaptan.

- enhancing reliability of the mobile mixer's electrical supply and improving the devices used to feed the neutralising mix;
- redesigning the unit's gas treatment system based on a conservative scenario of accidental emissions, to be capable of treating 100% of the mercaptans and alkenes released according to this scenario, while raising online analyser performance: extended measurement range, measurement of total sulphur content, etc.

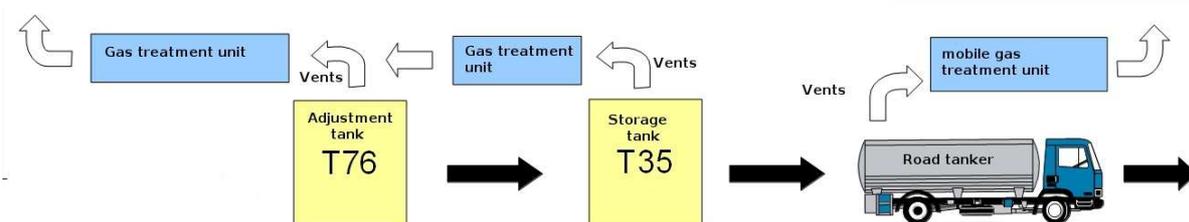
Fig. 5: Neutralisation and treatment of gases released during the accident (DREAL Agency)

An initial inerting procedure was undertaken by means of adding an aqueous zinc oxide solution in the tank; furthermore, chlorine dioxide was injected into a washing column on the gaseous effluent treatment system. An electric short-circuit, followed by difficulties encountered when hooking up the device for mixing neutralising solution, wound up slowing the operation. Zinc oxide was injected a second time as this inerting procedure was ongoing, yet the tank temperature still exceeded 100°C. Around 11:15 am, the temperature began to drop, although the analyser at the stack outlet posted an error reading, indicating incomplete removal of the mercaptan. As of 10 am, strong smells had begun permeating the plant. Around 11:30 am, the operator activated the Internal Emergency Plan and notified the Environmental Agency. During the afternoon, a test intended to lower temperature by adding 5 tonnes of oil failed, as did a neutralisation test calling for the gradual introduction of 3 tonnes of calcium sulphonate into the tank.

Tuesday 22 and Wednesday 23 January: The local government (Rouen Prefecture) activated the External Emergency Plan at 10:35 am on Tuesday the 22. A revised product treatment protocol was designed and then validated by the Prefect. On Wednesday the 23 around 6 am, another neutralisation operation was launched with a low injection rate in order to better control the exothermic reaction, while limiting the risks of a runaway reaction and release of toxic gases above 75°C. The tank used for this purpose needed to be constantly cooled. The contents of tank T76 were injected in small quantities into a neutralising solution (composed of soda water and bleach) prepared in one of the unit's storage tanks (T35). A 30-min interval was respected between each transfer step in order to: homogenise the mix, limit heating (exothermic reaction), and monitor the reaction (Fig. 5). All vapour released during transfers was still being routed into gas washing columns (the plant's stationary installations for tanks T76 and T35, mobile installations for the vents on road tankers handling the neutralised product).

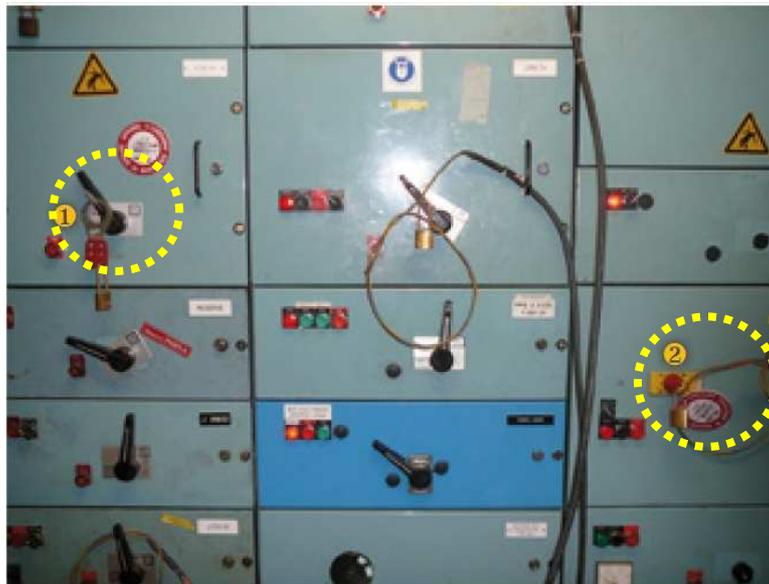
Fig. 11: View of the control board for the process implicated in the accident (Preventique Group)

The starting point of the sequence that led to this accident consisted of human error. On Friday 18 January, the technician on duty mistakenly turned on the adjustment tank stirrer instead of the recirculation pump on the control board, despite a different labelling and triggering mode (pushbutton for the stirrer and a handle for the pump, see Fig. 11). He then failed to turn off the stirrer when returning to the unit to start up the pump after noticing its idle status on the control room display. This stirrer did not draw any special attention from technical staff due to the fact it had, in theory, been decommissioned for several years.

1 . HANDLE OF THE RECIRCULATION PUMP

2. START BUTTON OF THE STIRRER

- **Inadequate control over maintenance operations:** Even though the stirrer start-up switch on the control board had been decommissioned in 2006 (it had become apparent that the stirrer was adversely affecting the quality of finished products by virtue of generating particles), poor supervision of maintenance operations conducted on the adjustment tank later led to the accidental commissioning of the stirrer.

- maintaining the adjustment tank stirrer for the purpose of homogenising the product mix with a neutralising solution in the event of decomposition. Stirrer activation either locally or remotely will only be possible via an automated system activated by authorised personnel and solely in the event of ZDDP decomposition;

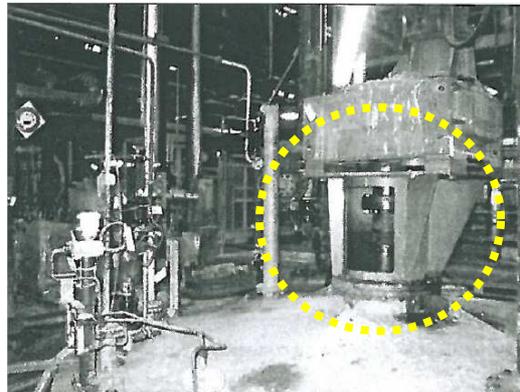
Fig. 12: Stirrer motor and shaft visible on the upper part of adjustment tank T76 (plant operator)

Subsequently, a "collective error" stemming from the failure to detect the temperature rise in time to prevent the accident from occurring can definitely be cited. During the ensuing weekend, the technicians assigned to monitor the installation failed to notice that the stirrer was operational, despite the indicator light being lit on the control board and the visibility they had of the stirrer shaft rotating at the top of the tank (Fig. 12). On Sunday 20 January, the technicians on duty in the control room also showed a lack of concern for an eventual gradual temperature rise in the tank. Since Friday, the tank's recirculation pump had been shut down and temperature detection in the recirculation loop was no longer indicating the actual temperature existing inside the tank.

This sequence, as part of the production context (with the product remaining in the adjustment tank due to reduced market demand and arriving at a normal temperature of 94°C) and unit configuration (heat-insulated tank, continuous operation of the stirrer, causing the product to heat by 1°C/hr⁹ as of Saturday night), initiated a slow ZDDP decomposition reaction, with temperature in the tank surpassing 110°C by 8 am Monday morning.

- **Poor management of change:** Unlike the pump, the stirrer had not use in the process and furthermore its operating status was not relayed to the control room. The unit's technical staff had not been given specific instructions on the stirrer's condition or its manual activation. The adjustment tank, used previously in another process, had been transferred to the ZDDP unit in 1997 without any prior "management of change" type of analysis that could have revealed the need to eliminate the stirrer or, at the very least,¹¹ allowed technicians to learn of its operating status. In addition, technicians had not been made aware of the potential consequences of a rotating stirrer for process safety. During their rounds, technicians were thus concentrating on a visual inspection of other indicators and equipment inside the building, even though the indicator was lit and the stirrer shaft was visibly rotating at the top of the tank.

- removing the adjustment tank heat insulation and procuring cooling systems for 15-minute availability on those unit tanks and exchangers not equipped with such cooling devices;
