Flooding strikes a solvent recycling factory

7 May 2014

Buchères (Aube)

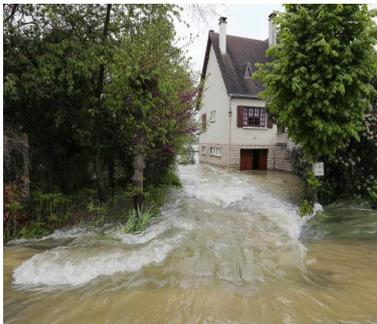
Rising SEINE water (ARR)

On 6 May 2013 at 11 am, the Aube Department Prefecture informed the factory operator that subsequent to a period of intense rainfall, the SEINE River was expected to overflow its banks around nightfall. A meeting of the crisis response unit was held at the Prefecture with mayors of the various municipalities concerned. The Prefect requested that each municipality activate its rescue plan, and the mayors decided to adopt all prevention measures necessary to save the population and local companies. At the end of 6 May, Departmental Fire and Emergency Services visited city districts showing the potential for flooding to notify residents.

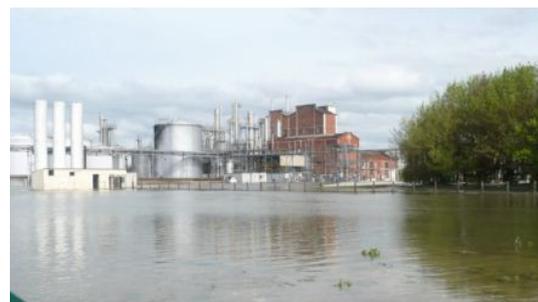
Chemical plant overwhelmed by water
(source: DREAL Champagne-Ardenne)

The next morning, on 7 May, the site was totally flooded, with the exception of the biomass storage zone and the barrelling workshop. Water level in the facility was varying between 10 cm and 1.50 m, depending on the specific spot.

As regards the chemical plant, when the water reached its high point on-site, the levels recorded ranged between 10 cm and 1 m on the premises, and up to 1.5 m on the parking lot.

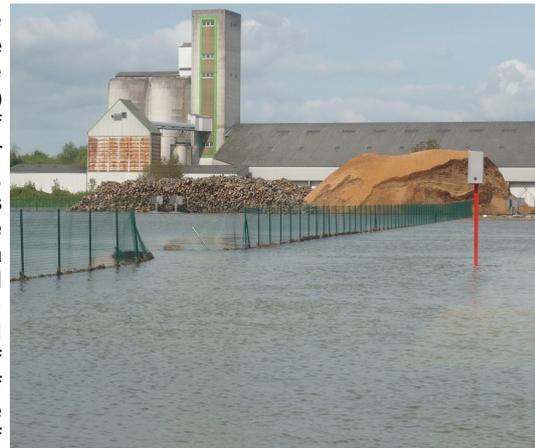
Wood storage at the plant overwhelmed by water
(Source: DREAL Champagne-Ardenne)

The large quantity of wood stored on the dedicated platform prevented the full removal of these contents despite the flood warning issued. The woodpile got slightly moved through flotation during the flood period (trunks and boards).

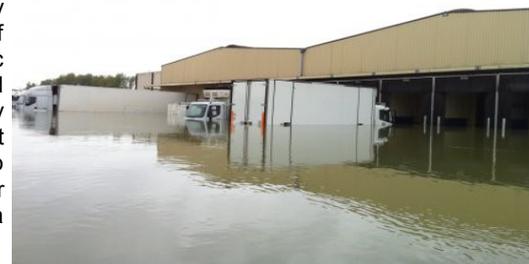
This flooding event affected several companies (ARIA nos. 43787, 43789, 43791) within the Buchères industrial park, where this chemical complex was located, in addition to nearby dwellings. 30 homes were flooded to some extent. Torrents of water and sludge advanced at high flow rates. The geographic territories most adversely affected by this flood were designated natural disaster zones. Hydrocarbon pollution caused by transport firms was also reported. Fields and gardens were not spared. The Prefecture, assisted by a local farmer, decided to build a wall of sandbags to protect the Troyes municipal water pumping station and thereby avoid the entire metropolitan area losing its drinking water supply.

Loading platforms at the neighbouring firm (ARR)

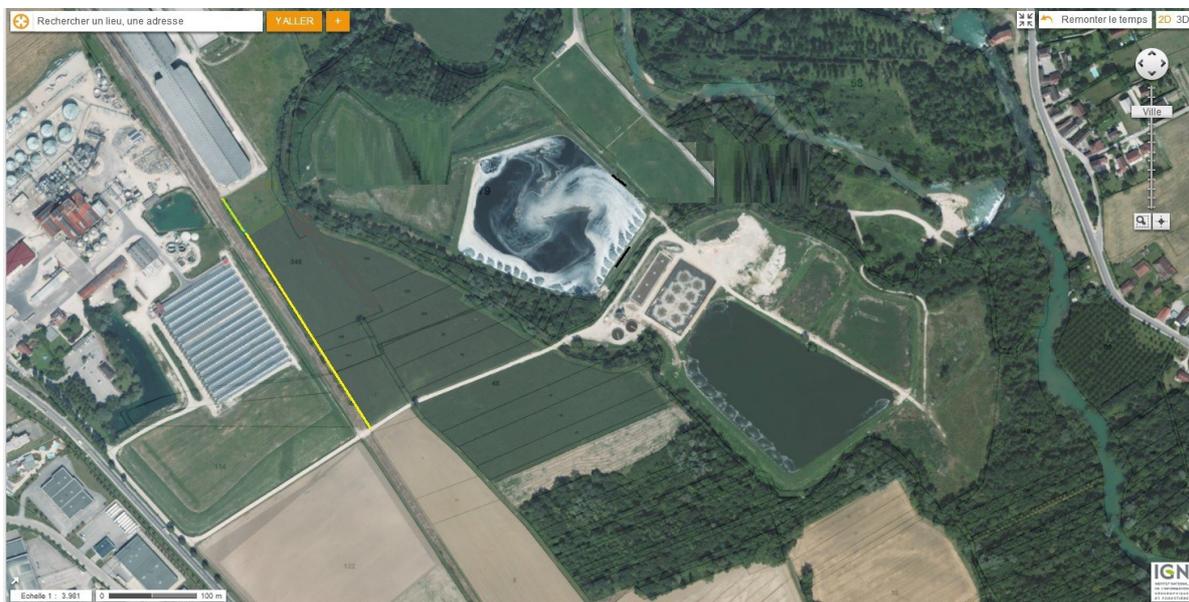
The Prefecture and departmental fire services decided to dig a trench down the middle of the departmental highway leading to the Buchères train station for the purpose of inserting a culvert to drain water that had accumulated at the plant as well as at the neighbouring transport company. In response to the announcement of another flood event by week's end, the Prefect decided on Thursday, 15 May, to build a 400 m long, 3 m wide dyke to protect the district surrounding the train station and adjacent businesses. An earthworks firm was hired and, with the assistance of 20 railway ballast cars, the dyke could be erected in 3 days.

Depiction (in yellow) of the dyke built during this flood episode (ARR operator)

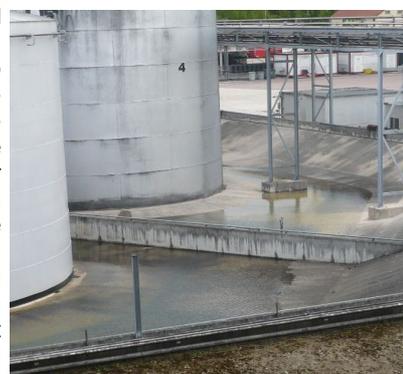
Storage facilities dedicated to flammable liquids and liquid chemicals were protected by retention walls that served to prevent water from flowing towards the tanks (with these retention basins designed to mitigate the consequences of tank leaks). Nonetheless, the presence of water (approx. 15 to 30 cm) inside the oldest basins made it possible to establish that their seals had been breached.

Retention basin for an unsealed tank (Source: DREAL Champagne-Ardenne)

This upper-tier SEVESO-rated chemical complex had been specially monitored throughout the flood episode, notably with the close watch of Classified Facilities inspectors, who were in daily contact with the operator. Two inspections were conducted: in order to authorise the quick resumption of site activity under safe conditions, inspectors proposed measures to compensate for the absence of safety data transmission to the control room. To avoid the risk of overflow around flammable product storage tanks, the operator proceeded with a manual gauging of the tanks several times a day. This gradual restart first focused on three tanks out of the 20 located on-site. The flood served to indicate breaches in the seal on some of the retention facilities for flammable liquid tanks. The more recent retention structures had remained dry, whereas the older ones, exposed to the thrust of water, had flooded from their base (joint ruptures). Classified Facilities inspectors requested that upcoming verifications, in accordance with the approved industrial installation modernisation plan, include specific points on the condition of both basins and blocks, with a ranking of the observed disorders based on available professional guides and an indication of associated repair time constraints. The operator had initiated a comprehensive and detailed expert appraisal of all basins, including an inspection of seals and repair specifications as needed.

- The retention basin seal defects, which could be identified indirectly through this flood episode, are listed as a verification step in the industrial installation modernisation plan. In 2010, the government enacted a control plan for risks related to ageing industrial installations, pipelines transporting hazardous substances and pressure equipment. This case helps reinforce the need to continue verification actions, by means of site inspections in facilities requiring such authorisations, aimed at compliance with regulatory indications for all equipment targeted by the classified facilities modernisation plan (Ministerial decrees issued on 3rd and 4th October, 2010).
