Accident during an "Emergency Plan" drill

11 June 2013

Tilloy-Lez-Cambrai (Nord)

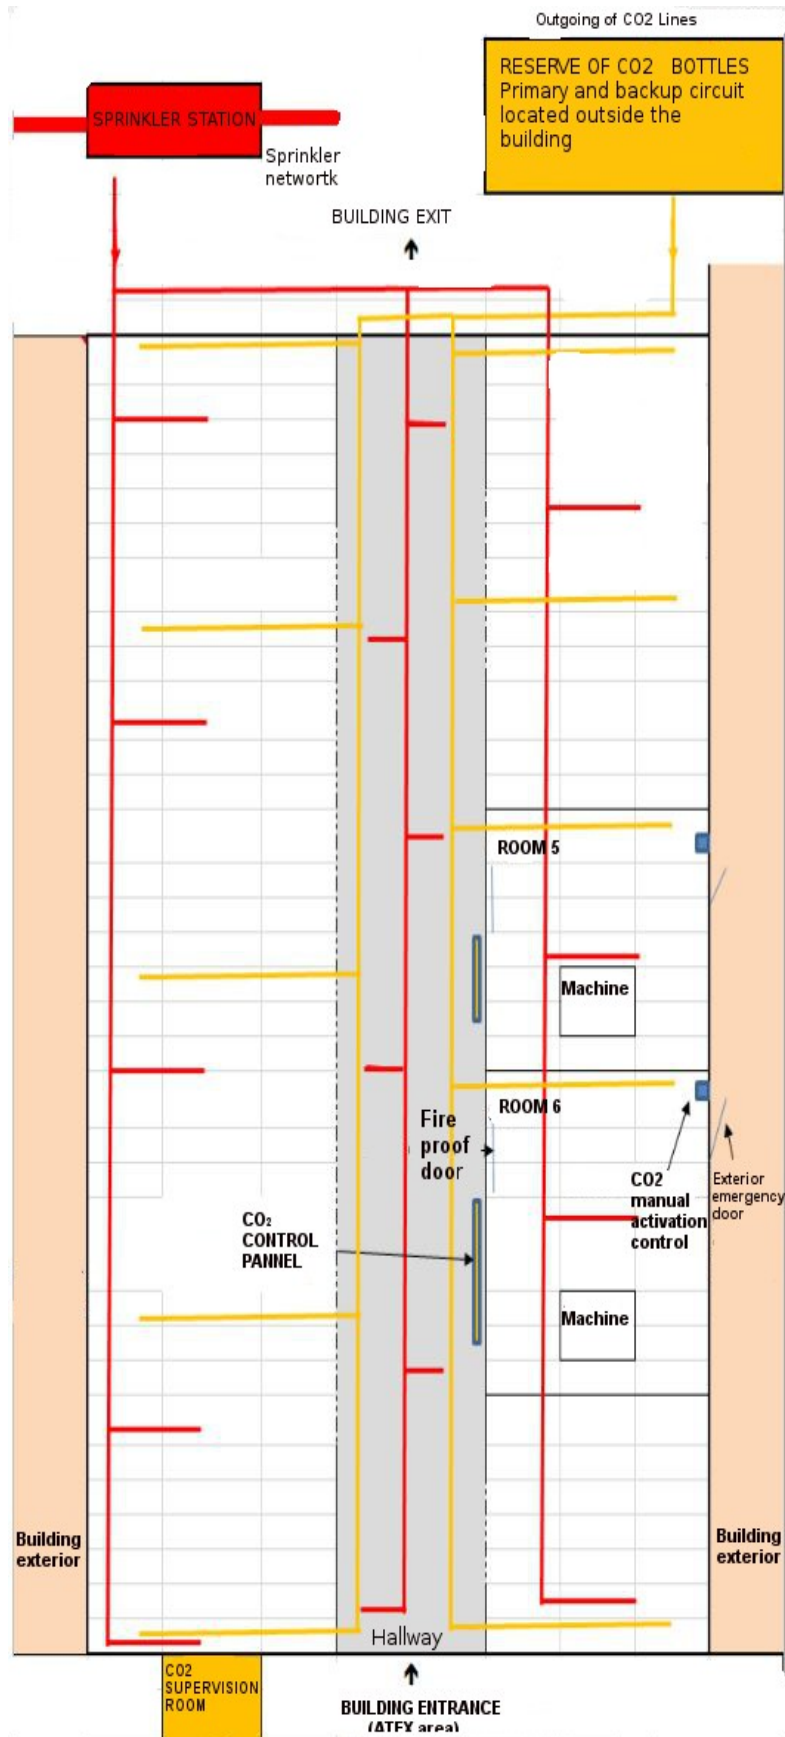
This accident occurred in a building housing the Adhesives unit (Fig. 2); the building contained a total of 7 rooms. Mixing workshop room no. 6 was laid out with 2 exit doors: a primary door accessing the main building hallway and featuring a fire proof door with a controlled closing mechanism; and an emergency door leading outside the building and fitted with an anti-panic closing system.

Each room was equipped with a fire extinction system relying on CO₂ injection that operated as follows:

- presence of 2 fire detection cells: thermal and optical (flame detector);
- one of these means of detection triggered the personnel evacuation siren;
- the two detection sources (if simultaneous confirmation of both alarms) controlled automatic CO₂ injection activation in the targeted room, after an 18 to 20 seconds self-timer delay, allowing the time necessary for employees present to evacuate;
- at the end of the self-timer delay, the fire door of the particular room closed automatically.

CO₂ was injected into the rooms by saturation thanks to a reserve composed of 76 kg bottles located outside the building. In room No. 6, the system comprised 8 injection nozzles positioned at the top and capable of being activated in either automatic or manual mode (with a manual CO₂ trigger placed near the emergency doors).

To complete this fire protection system, the building was also protected by a sprinkler type installation (Fig. 2).

Figure 2: Fire protection devices inside the adhesive workshop building (source: DREAL NPDC)

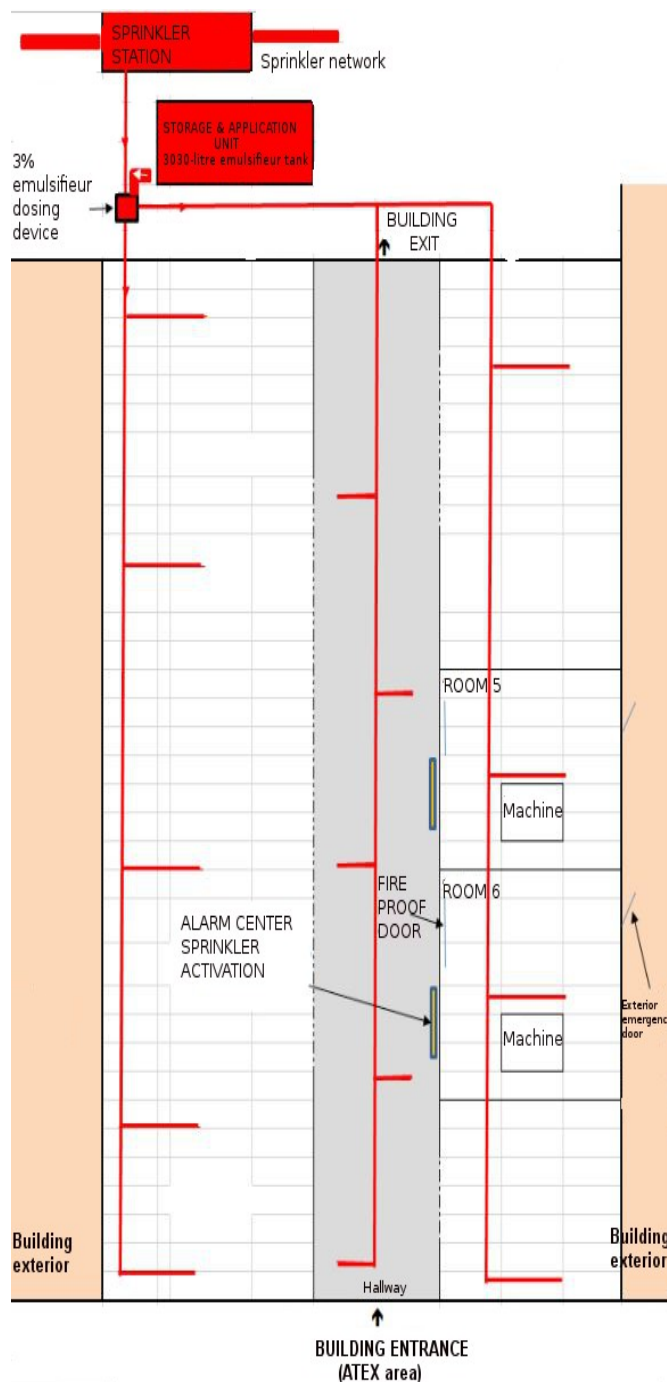
Figure 3 : New configuration of the fire protection systems deployed in the adhesive workshop building (source: DREAL NPDC)

This accident led the facility operator to reflect on the relevance of his CO₂ protection installation. An audit, requested of the CNPP fire safety body, convinced the operator to change his fire protection strategy. CO₂ injection was replaced by a modification to the existing sprinkler system, with the addition of a 3030 litre emulsifier tank.

Modification to the existing sprinkler system, coupled with the addition of emulsifier, was performed during the 1st quarter 2015. Each room in the adhesive workshop is now equipped with the following detection system (Fig. 3):

- 2 fire detection cells: one thermal the other optical;
- One or the other of these 2 detection devices controls the overall site's personnel evacuation siren, with an alarm relay to the safety unit;
- Both detections (provided confirmation of the two alarms) are able to trigger: the safety servo-controls (energy outage), the room's pneumatic and electrical siren, and the alarm relay to the safety unit.
