Pneumatic explosion during an intervention on a pipe at a pyrotechnic plant

30 July 2014

**Pont de Buis (Finistère)
FRANCE**

Pyrotechnics
Pneumatic explosion
Organisation /
Procedures

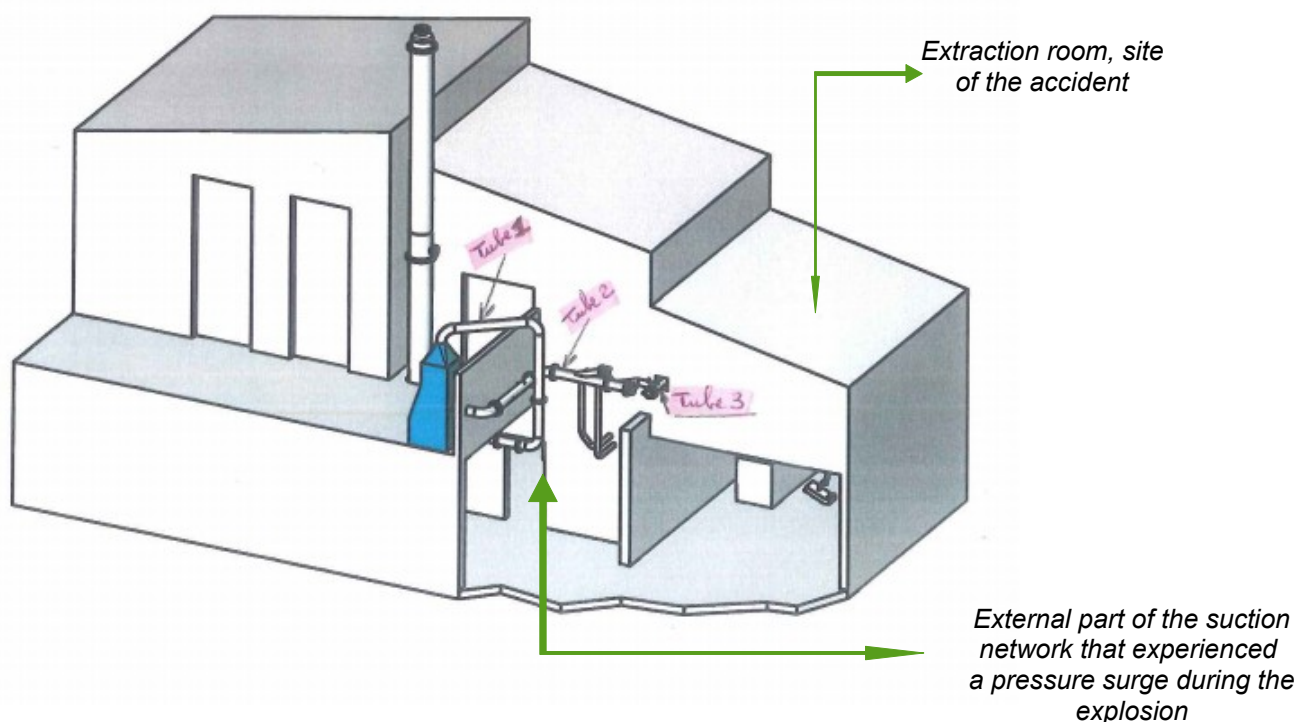
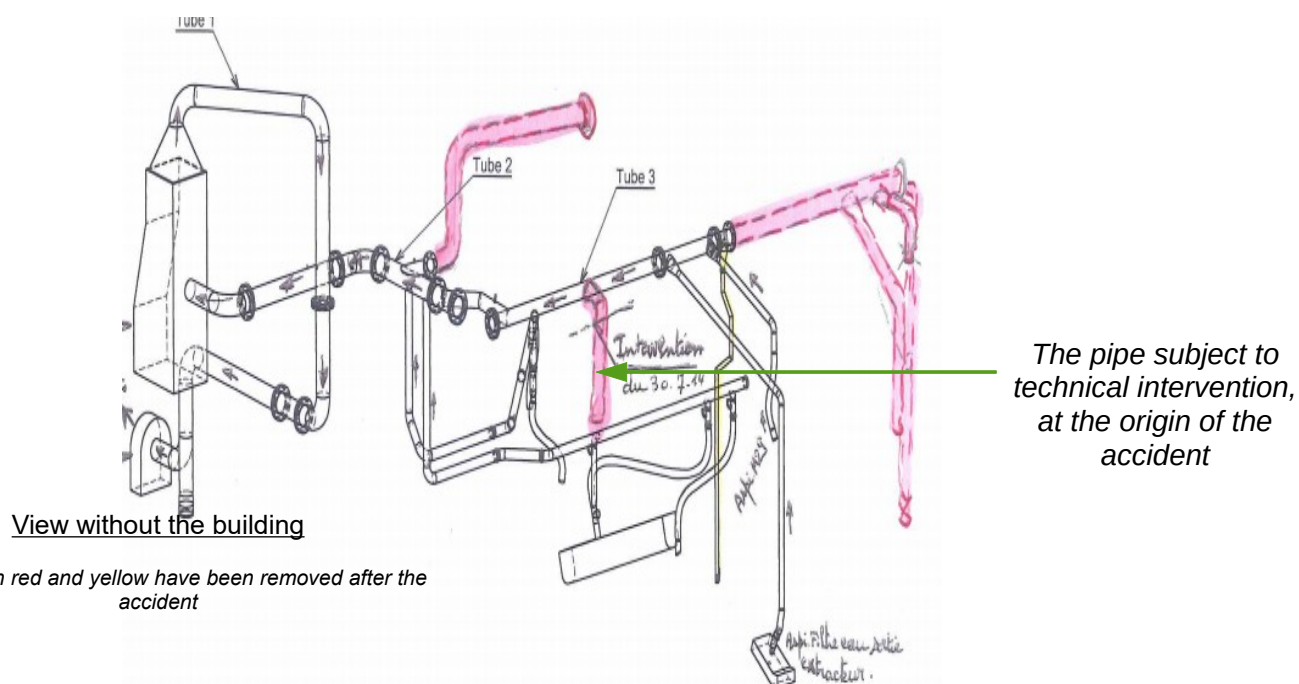
The pipes in red and yellow have been removed after the accident

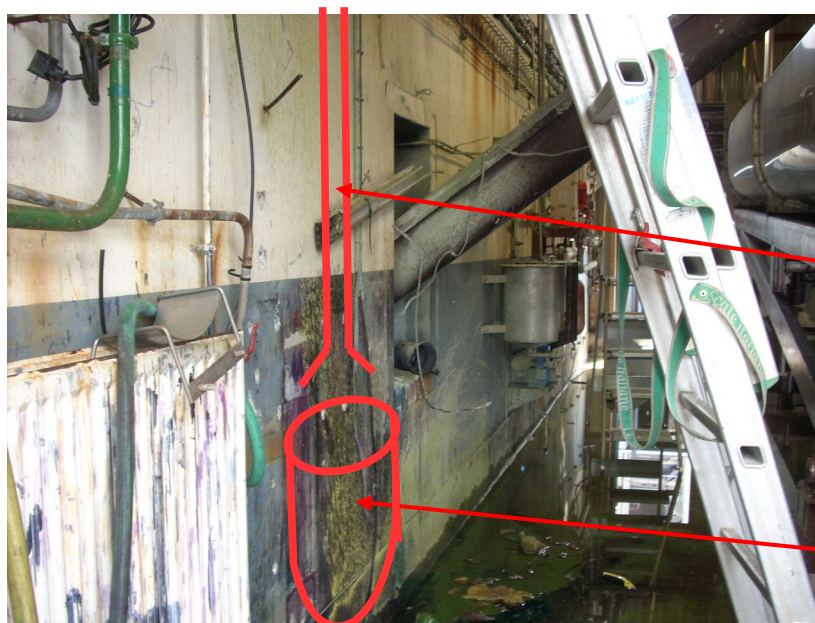
Location of the suction pipe that was rendered inoperable, i.e. the origin of this accident

Location of the former dye tank (under the pipe at the origin of the explosion)

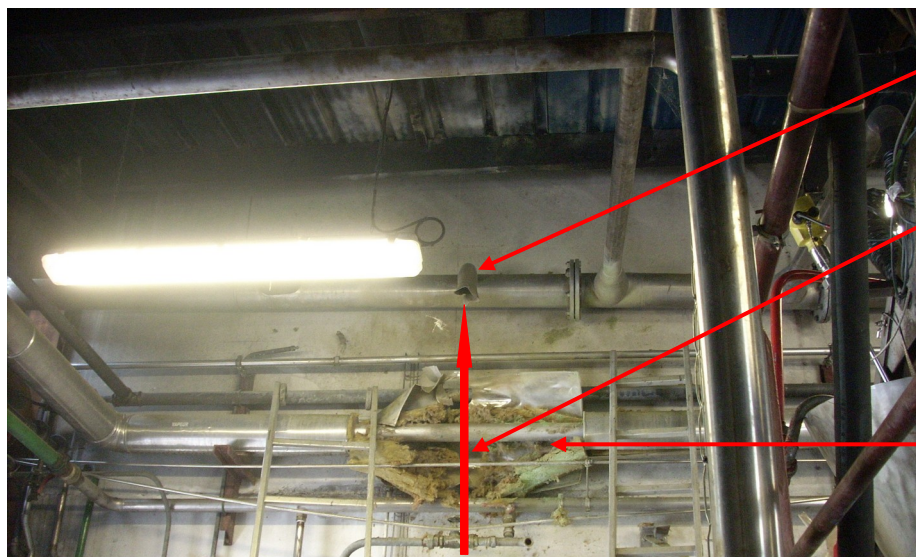
The powerful pressure surge associated with the explosion led to considerable metal debris being blasted within the room, as well as ruptures at several vulnerable parts of the suction network. In addition, metal foil installed on flanges was ripped open.

Remainder of the pipe torn off by the explosion

Location of the stripped "idle" pipe section

Damage caused by the explosion on heat insulation of a nearby pipe

- The pipes damaged by the explosion were repaired. **Rupture discs were installed on hinged flanges**; they could be manually opened to observe the inside of piping and verify the degree of cleaning efficiency.
- Broadly speaking, in order to limit the risks of pyrotechnic residue being present inside hollow bodies, the operator preferred **replacing former single-piece ducts with split stainless steel pipes** easy to maintain and inspect.
- The operator installed **detection equipment** to improve the identification of pyrotechnic substances within hollow bodies. A camera was purchased to visualise pipe interiors, and nitrocellulose detection products were also envisaged.

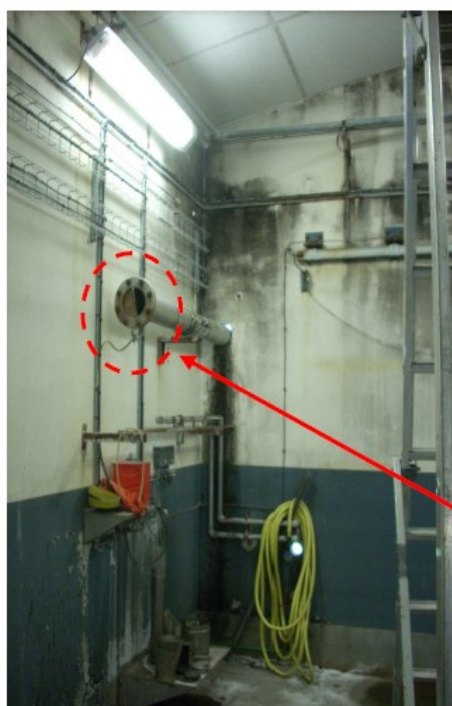
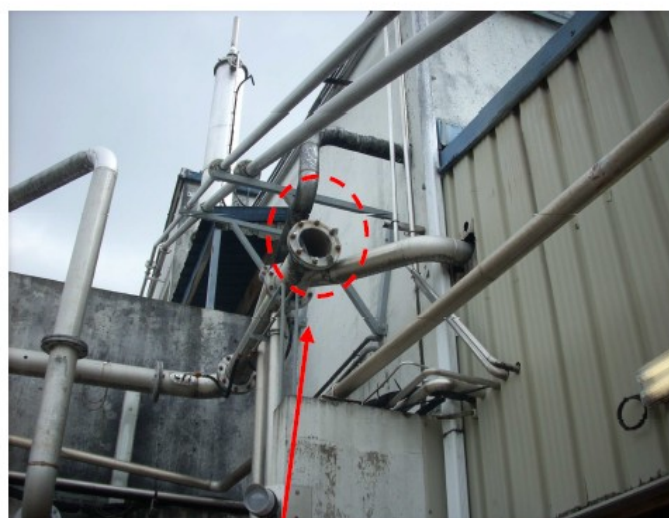
Plugs and/or foil present on the suction network that had opened subsequent to the pressure surge generated by the explosion

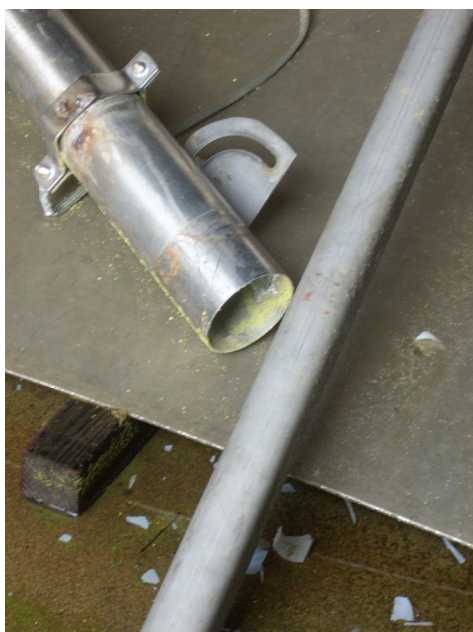
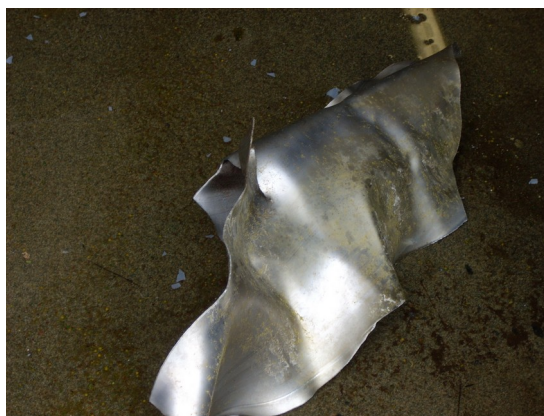
Pyrotechnic dust residue (a yellowish substance with powdery texture) was present on the metal debris of the stripped pipe (found on the floor of the workshop and outside the building, along the path of the foil that had been ripped apart). These observations indicated that **the pipe had not been adequately washed** during preliminary rinsing steps.

Metal debris, from the pipe blasted by the explosion, found on the floor. The picture on the left shows residue from pyrotechnic dust (yellowish) covering the inner pipe wall.

The fire most likely broke out due to ignition of this powder residue and/or pyrotechnic dust accumulated inside the pipe. This build-up was correlated with the **heating produced by friction of the metal saw blade on the stainless steel suction pipe (hotspot)**.

The operator extended and consolidated its dedicated procedure. **The cleaning guideline would contain a checklist** detailing, workshop by workshop, the sequence of preliminary washing operations to be performed depending on the specific situation (index change, weekly cleaning, installation shutdown). A fact sheet recorded the successful execution of these operations and was submitted to a manager for final validation. These preliminary measures allowed the manager responsible for the validation step to authorise or reject subsequent works. This modified order, with a double validation required by both technician and management prior repairs, was tested during the winter 2014 closure.
