# Acetonitrile spill in a pharmaceutical plant

06/09/2021

Aramon (Gard)

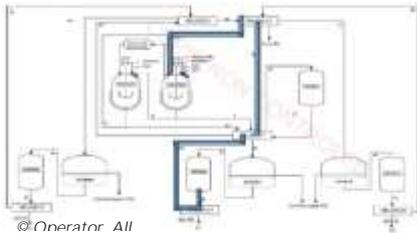
**Figure 1: Transfer circuit**

For this transfer, the technician had to set up a circuit connecting a receiving tank located on level 0 of the workshop to one of the two reactors located on level 6 metres.

The installation consists in connecting hoses between 3 distribution panels on level 0 (receiving tank level), level 3 m (intermediate panel) and level 6 m (reactor level).

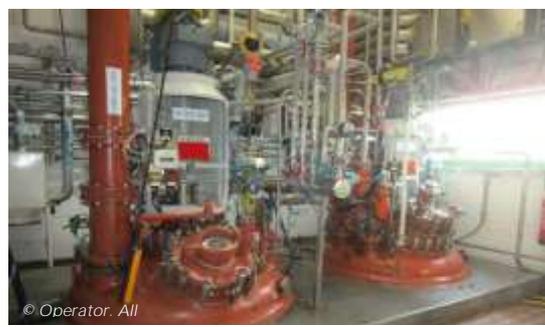
**Photo 2: Spread area (level 6 m)**

On Monday 6 September 2021, at approximately 3:45 am, a product transfer operation was in progress between the receiving tank and one of the two reactors in the workshop. Only half of the volume of the product had to be transferred. When the target level was reached, the technician went to the operations room to close the bottom valve of the receiving tank and stop the transfer. When arrived in the vicinity of the room, the technician noticed a leak of liquid flowing down through the levels. Because of this flow, the technician could not access the room to close the valve. The technician then went around the area of the leak and went to the upper level (+3 m) to see whether the leak was coming from the intermediate distribution panel on that floor. The technician noticed an even more abundant leak from the upper level (+6 m). By a circuitous route, the technician reached this level and noticed a large puddle on the floor and a stream of solvent between the two reactors. The technician then immediately went into the control room and

triggered the emergency stop at 03:55. In accordance with procedures in force, the technician broke the break-glass emergency box, which triggered the internal emergency plan alarm, evacuation of the workshop and lockdown of the facility. The discharge valve for discharging aqueous effluent from the site to the Rhône was closed. The emergency response team set up a safety perimeter. The measurements performed confirmed a high concentration of VOCs in the workshop. Ventilation of the premises was started, and a small hose station was used to dilute the leak on the floor and allow its rapid drainage to the chemical sewer and then the toxic waste basin of the wastewater treatment station. The internal emergency plan was lifted at 05:25 am.

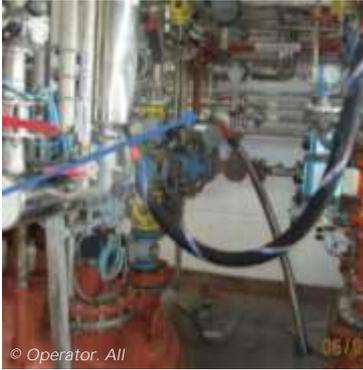
**Photo 3: Unconnected process hose**

The spill occurred through a process hose that was not connected to the transfer line and not plugged.

The entire receiving tank containing 2,600 L spilled. There were no injuries and no impacts outside the site (no environmental consequences, no need to implement measures to protect the public).

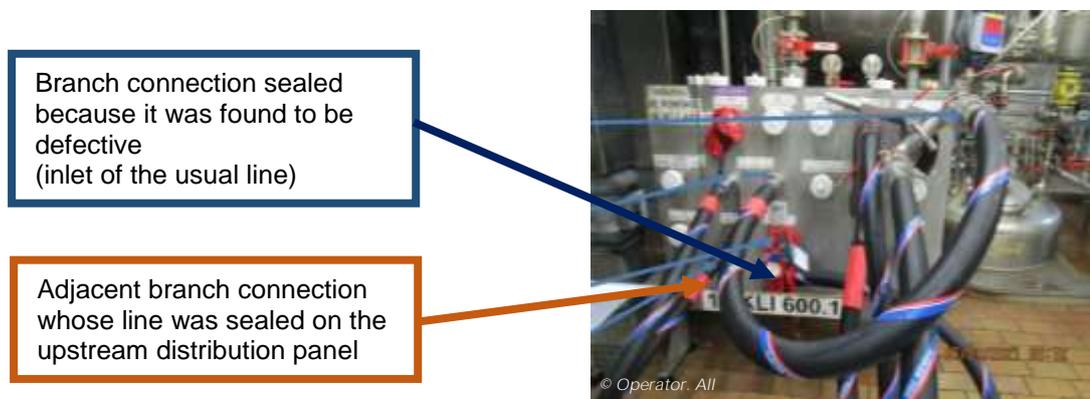
Photo 4: Distribution panel, level +3 m

In this case, about 10 days before the incident, at the beginning of the morning shift, a technician had found that the branch connection of the line connecting the 0 m level distribution panel to the +3 m level distribution panel was defective. The production team called the on-call service staff who decided to stop the transfer of product that was to take place, which was non-blocking for the production of the current batch, and to request a maintenance repair action to be taken before the next production batch, scheduled for 6 days later. The repair was rated as medium priority because it did not block production, and was scheduled to take place 4 days later. In view of the scheduled rapid response time, which in this case did not require modification of the line, the workshop manager did not consider it necessary to draw up an undescribed situation sheet.

However, the following day, faced with emergencies that had to be dealt with as a priority, the maintenance department postponed the repair. A circuit deviation was set up for the next transfer 5 days later. The deviation consisted in installing a hose on the fixed line located upstream of the intermediate distribution panel (level +3 m) and connecting the reactor directly, bypassing the intermediate distribution panels (level +3 m) and upstream (level +6 m). At the end of the operation, the hose was disconnected from the reactor and not plugged. On the day of the incident, another 5 days later, during a new product transfer, the information on this modification was lost.

On the day of the incident, on the intermediate distribution panel (level +3 m), the inlet of the usual line, which corresponds to the branch connection found to be defective, was physically sealed. The adjacent branch connection had an identification whose numbers and letters are similar to the defective branch connection. In addition, the label was slightly damaged as a result of repeated contact with the transferred substances. This connection, which was no longer useful, was sealed on the upstream distribution panel (level 0 m) but not on the intermediate distribution panel on the level where the technician was (level +3 m). Because the technician did not have the circuit modification information, the technician automatically connected the hose to the adjacent branch connection (thinking it was being connected at the correct location). The technician therefore incorrectly thought that the resulting transfer circuit complied with the manufacturing sheet.

- sharing of information on the temporary assembly in place with the teams and making a room posting;
- sealing off of the branch connection of the line no longer used on the intermediate distribution panel (level +3 m);
- update of the branch connection identification labels;
- new awareness raising in technicians regarding pressure tests;
- reminder to the teams and performance of a field observation visit concerning the current placement of the plugs on the lines.
