Transboundary pollution accident River Daugava (Latvia)

23 March 2007

THE ACCIDENT, ITS CHRONOLOGY, EFFECTS AND CONSEQUENCES

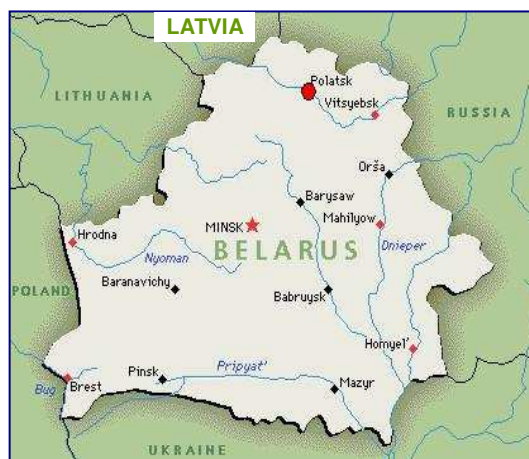
Latvian Coast Guard Service

The rupture of a 377-millimeters oil pipeline for 5 hours resulted in approximately 120 tonnes of diesel fuel spilled into River Ulla and then into River Daugava.

Pollution from this source affected 2 countries – Latvia and Belarus. Leakage of approximately 120 tonnes of diesel fuel also contaminated 1.2 hectares of land at the source. The oil slick extended over 100 kilometres downstream, around 30 per cent of the river's width has been affected by the spill. The clean-up operation prevented much significant long-term damage from the spill.

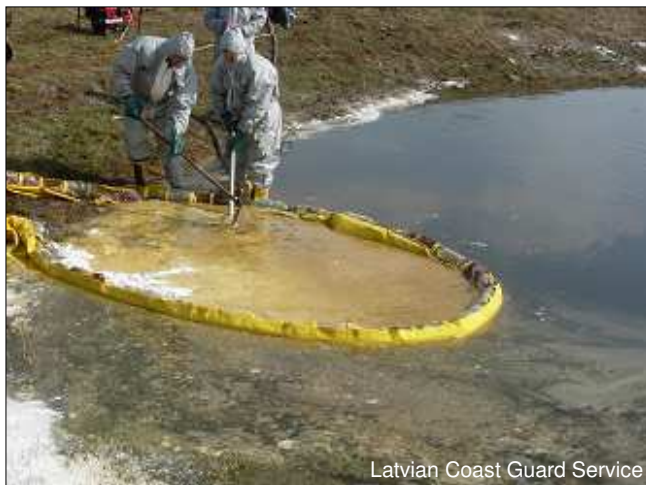
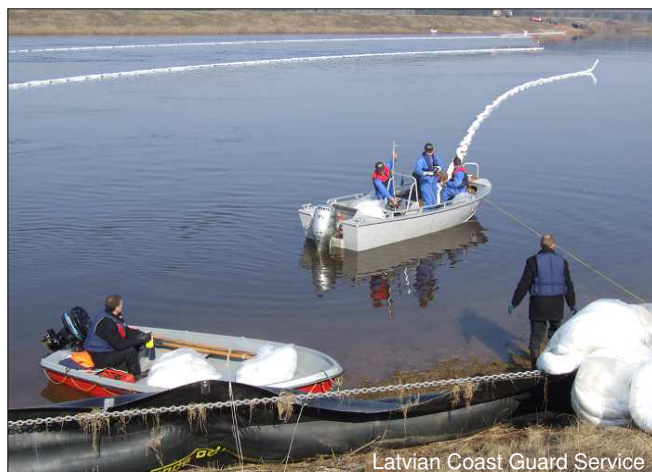
The second attempt of deployment of booms 50 kilometres downstream was successful. In total more than 4 tonnes of oil products pollution was collected. The size of the spill was constantly fluctuating and the main concern was that the leakage would continue longer than we predicted initially.

Observation of 40 sites in affected area was made during clean-up operation and during monitoring of affected area later on.

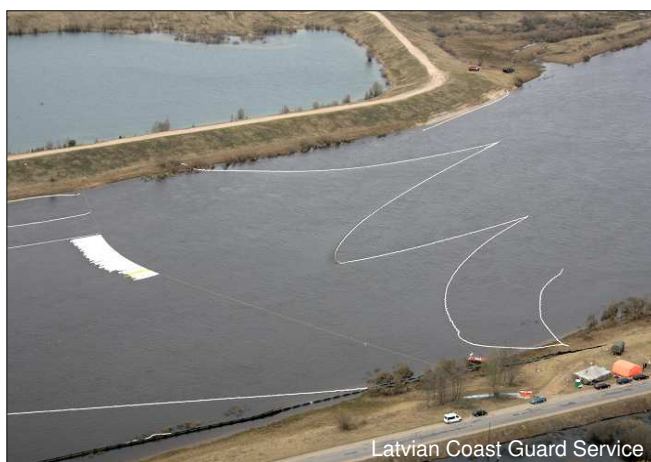
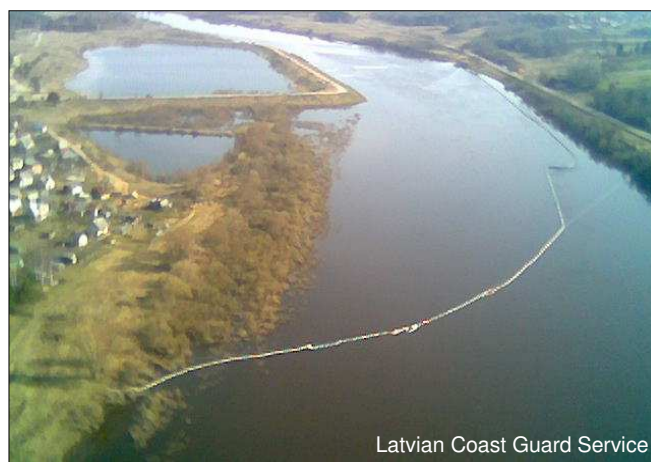
Co-ordination of emergency operations was established already at the beginning by convening the Government Crisis Management Council. Also international communication with Belarus was established through the Ministry of Foreign Affairs. Requests for assistance were dispatched to the neighbouring countries - Sweden, Estonia and Lithuania and emergency equipment was received, such as absorbent and river boom, as well as rescue brigades from Lithuania and Estonia.
