Spillage from a semi-buried jet fuel tank

December 30, 2005

Sainte-Marie – [Reunion Island]

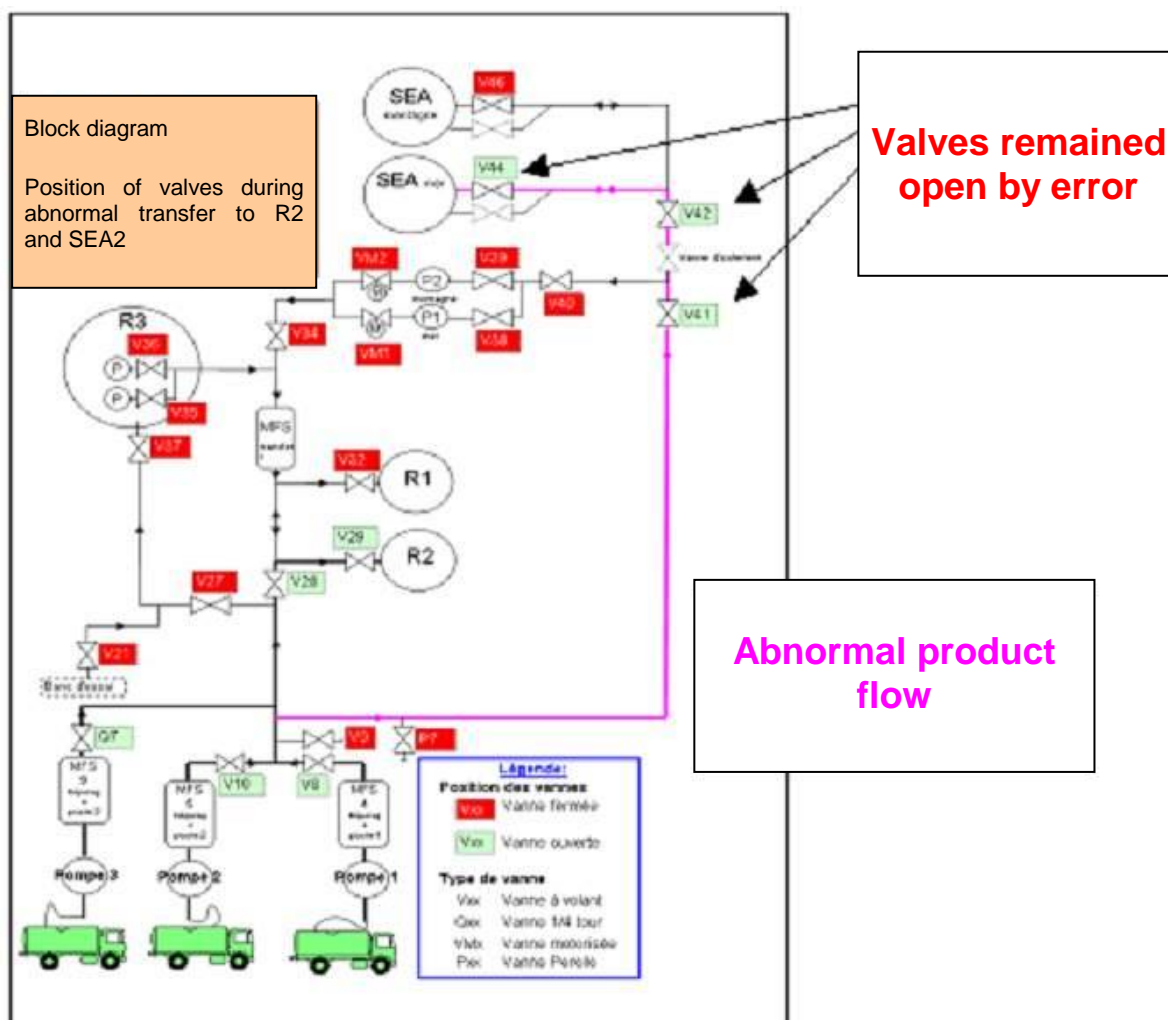
The high level detection safety alarm on the SEA2 tank did not function.

At around 8.30 am, a worker of the depot B noted jet fuel pouring from the two vents on the SEA2 tank: a phone call was made to the facility A to stop the transfer operation. The facility's emergency shutdown was activated which immediately stopped the transfer operation.

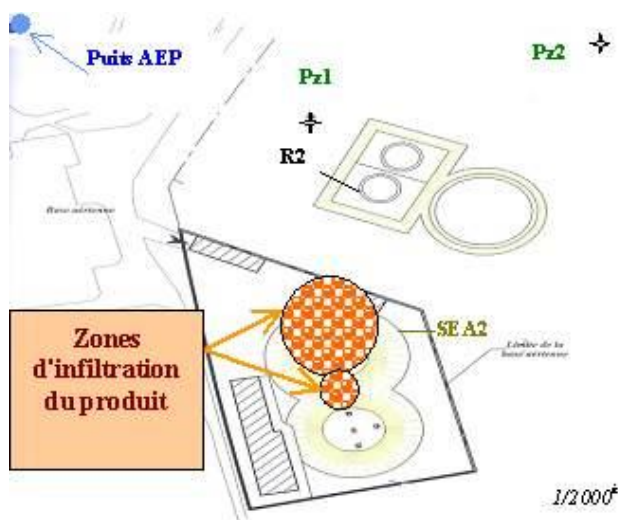
The quantity of jet fuel spilled was estimated at 33 m³. The product spilled onto the surface covering the underground tank and seeped into the ground, outside the bund and into the common parking lot in the zone B. The parking lot is connected to a hydrocarbon separator, which quickly became saturated. Roughly one hundred litres of hydrocarbons thus entered the rainwater drainage system that spills into the sea.
