Explosion of a superheater within a steam-cracking unit

15 July 2009

Saint-Avoid (Moselle)

Petrochemical industry
Gas explosion
Ignition/start-up
Instructions
Automatism/regulation

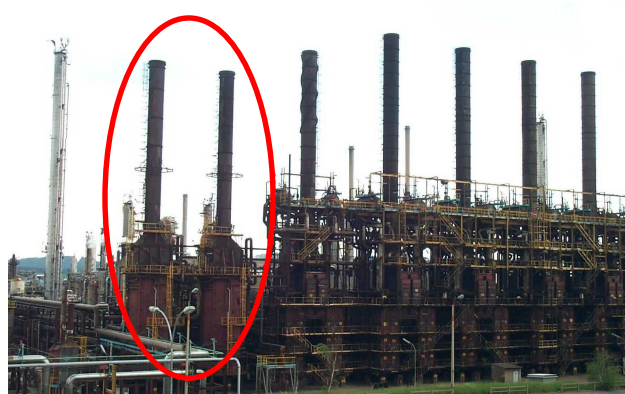
This facility comprised many pieces of equipment and machinery, including two superheaters (Fig. 2). Their role was to increase the temperature of vapour produced in the cracking furnaces so as to eliminate water droplets, through the use of 7 burners fed by a fuel oil-gas mix. This overheated vapour then served as the driving force behind the main cracked gas compressor (Fig. 3).

Fig. 2: View of the unit's two superheaters (RR)
