Fire on a stainless steel production line

23 December 2012

Gueugnon (Saône-et-Loire)

Metallurgical industry
Fire
Stripping
Fire detection
Fire extinguishing
Lockout
Maintenance
Hot spot
Backup power supply

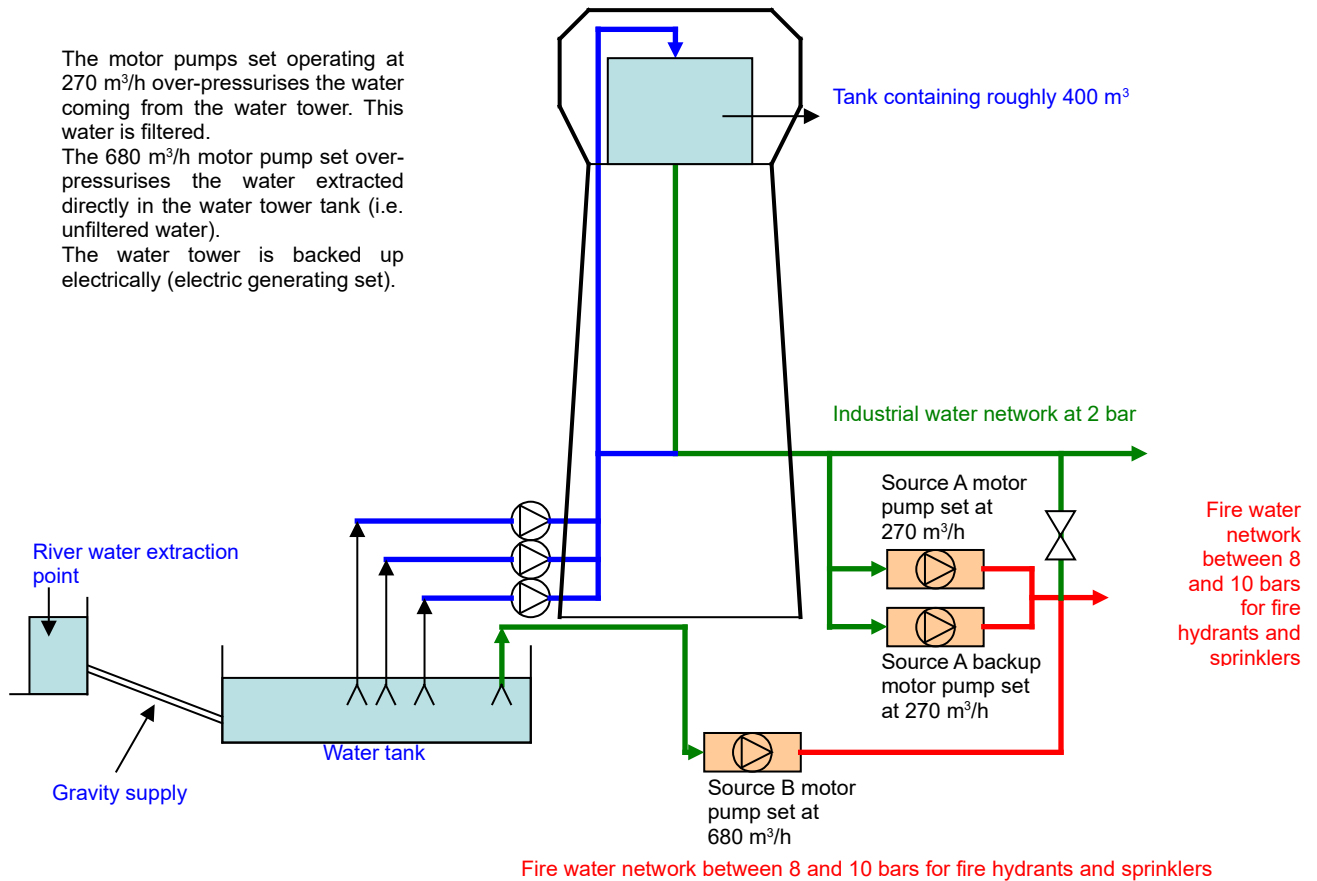
The 680 m³/hour motor pump set directly draws water into the reserve located below the water tower. The 2 motor pumps running at 270 m³/hour were fed via the water tower and industrial water network. The combination of these sets of pumps supplied the sprinkler protection system as well as the site's 23 fire hydrants and a portion of the fire hose cabinets.

On the day the fire broke out, both A motor pump sets at 270 m³/hour had been operational, while the B motor pump set (680 m³/hour) was down subsequent to a major malfunction that had occurred in July 2012 while treatment was underway.

The automatic start-up of the 680 m³/h motor pump set (source B) had been inoperable since July 2012 (even though several actions had been undertaken by the operator to repair the start-up mechanism during its idle period).
