Extended release of mercaptan at a chemical plant

21 January 2013

Rouen (Haute Normandie)
France

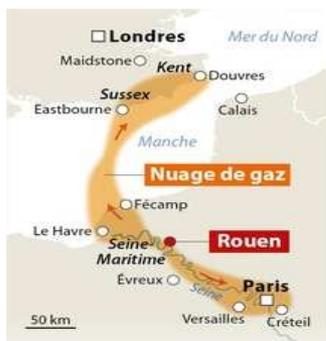
plume covered a wide geographic zone extending from the south of England to the Paris Metropolitan Area (Fig. 6), adversely affecting tens of thousands of individuals and, in some instances, responsible for headaches, nausea and temporary vomiting. The InVS Institute's health monitoring of population living near the plant indicated that the accident only had minor repercussions on the activity of health emergency services in the city of Rouen: fewer than 20 medical visits on 21 and 22 January, including two house calls (one of which was an asthma attack requiring hospital treatment).

Fig. 6: Synopsis of the plume's path over the period 21st to 23^d January 2013 (La Croix newspaper)

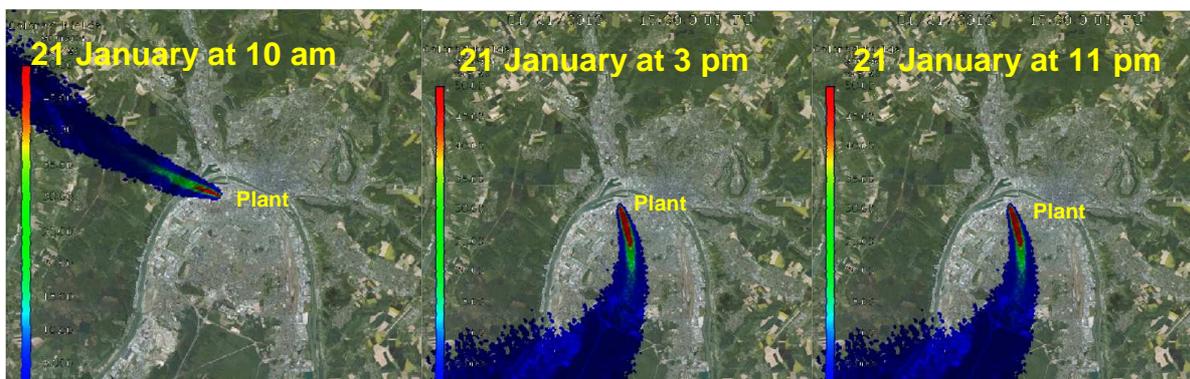
Monday 21 January: The operator received the initial complaints from neighbours around 10 am, at which point it activated the site's Internal Emergency Plan and informed municipalities in the vicinity, the Prefecture and the DREAL Environmental Agency. The Prefecture issued two press releases around 1 pm and 2:30 pm and gave statements to the local media (France Bleu, France 3 stations). At the same time, the GALA⁸ system notified the 33 town halls of municipalities potentially lying downwind of the plant (Fig. 7).

Fig. 7: Modelling of the foul-smelling plume in the vicinity of the plant on 21st January (Ineris)

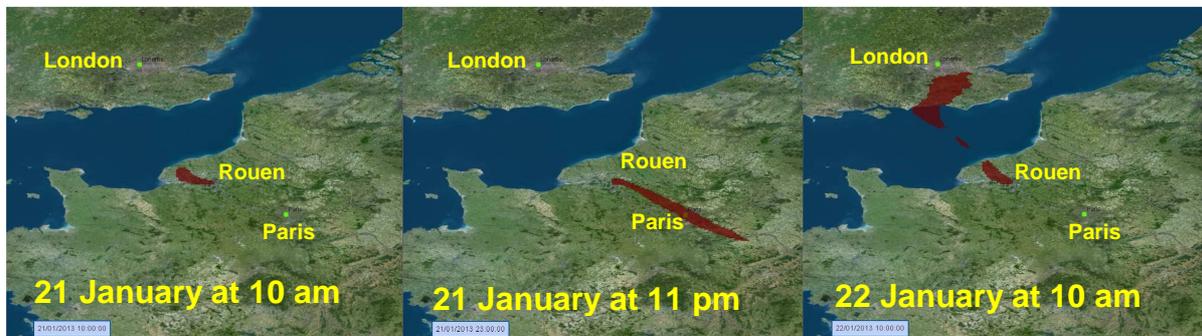
Tuesday 22 January: During the night, the wind changed directions several times. The smell of mercaptan first reached the Paris metropolitan area, then southern England (Figs. 6 and 9). The switchboard of Paris' fire department received over 10,000 calls during the morning hours. The French Ministry of the Interior disseminated an initial press release

Fig. 9: Modelling of the foul-smelling plume (shown in red) between 21st and 22nd January (Ineris)
