# Acetonitrile spill in a pharmaceutical plant

06/09/2021

Aramon (Gard)

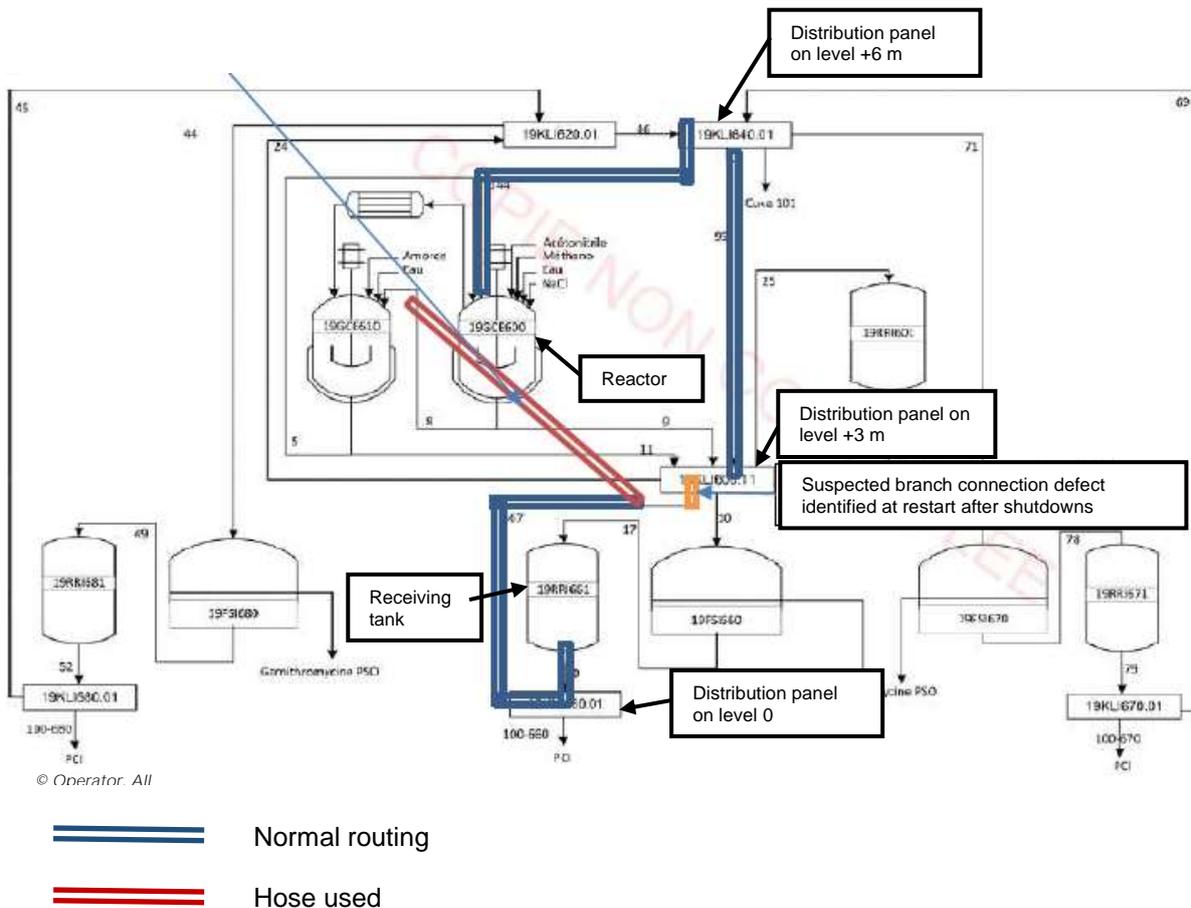
In this case, about 10 days before the incident, at the beginning of the morning shift, a technician had found that the branch connection of the line connecting the 0 m level distribution panel to the +3 m level distribution panel was defective. The production team called the on-call service staff who decided to stop the transfer of product that was to take place, which was non-blocking for the production of the current batch, and to request a maintenance repair action to be taken before the next production batch, scheduled for 6 days later. The repair was rated as medium priority because it did not block production, and was scheduled to take place 4 days later. In view of the scheduled rapid response time, which in this case did not require modification of the line, the workshop manager did not consider it necessary to draw up an undescribed situation sheet.

However, the following day, faced with emergencies that had to be dealt with as a priority, the maintenance department postponed the repair. A circuit deviation was set up for the next transfer 5 days later. The deviation consisted in installing a hose on the fixed line located upstream of the intermediate distribution panel (level +3 m) and connecting the reactor directly, bypassing the intermediate distribution panels (level +3 m) and upstream (level +6 m). At the end of the operation, the hose was disconnected from the reactor and not plugged. On the day of the incident, another 5 days later, during a new product transfer, the information on this modification was lost.

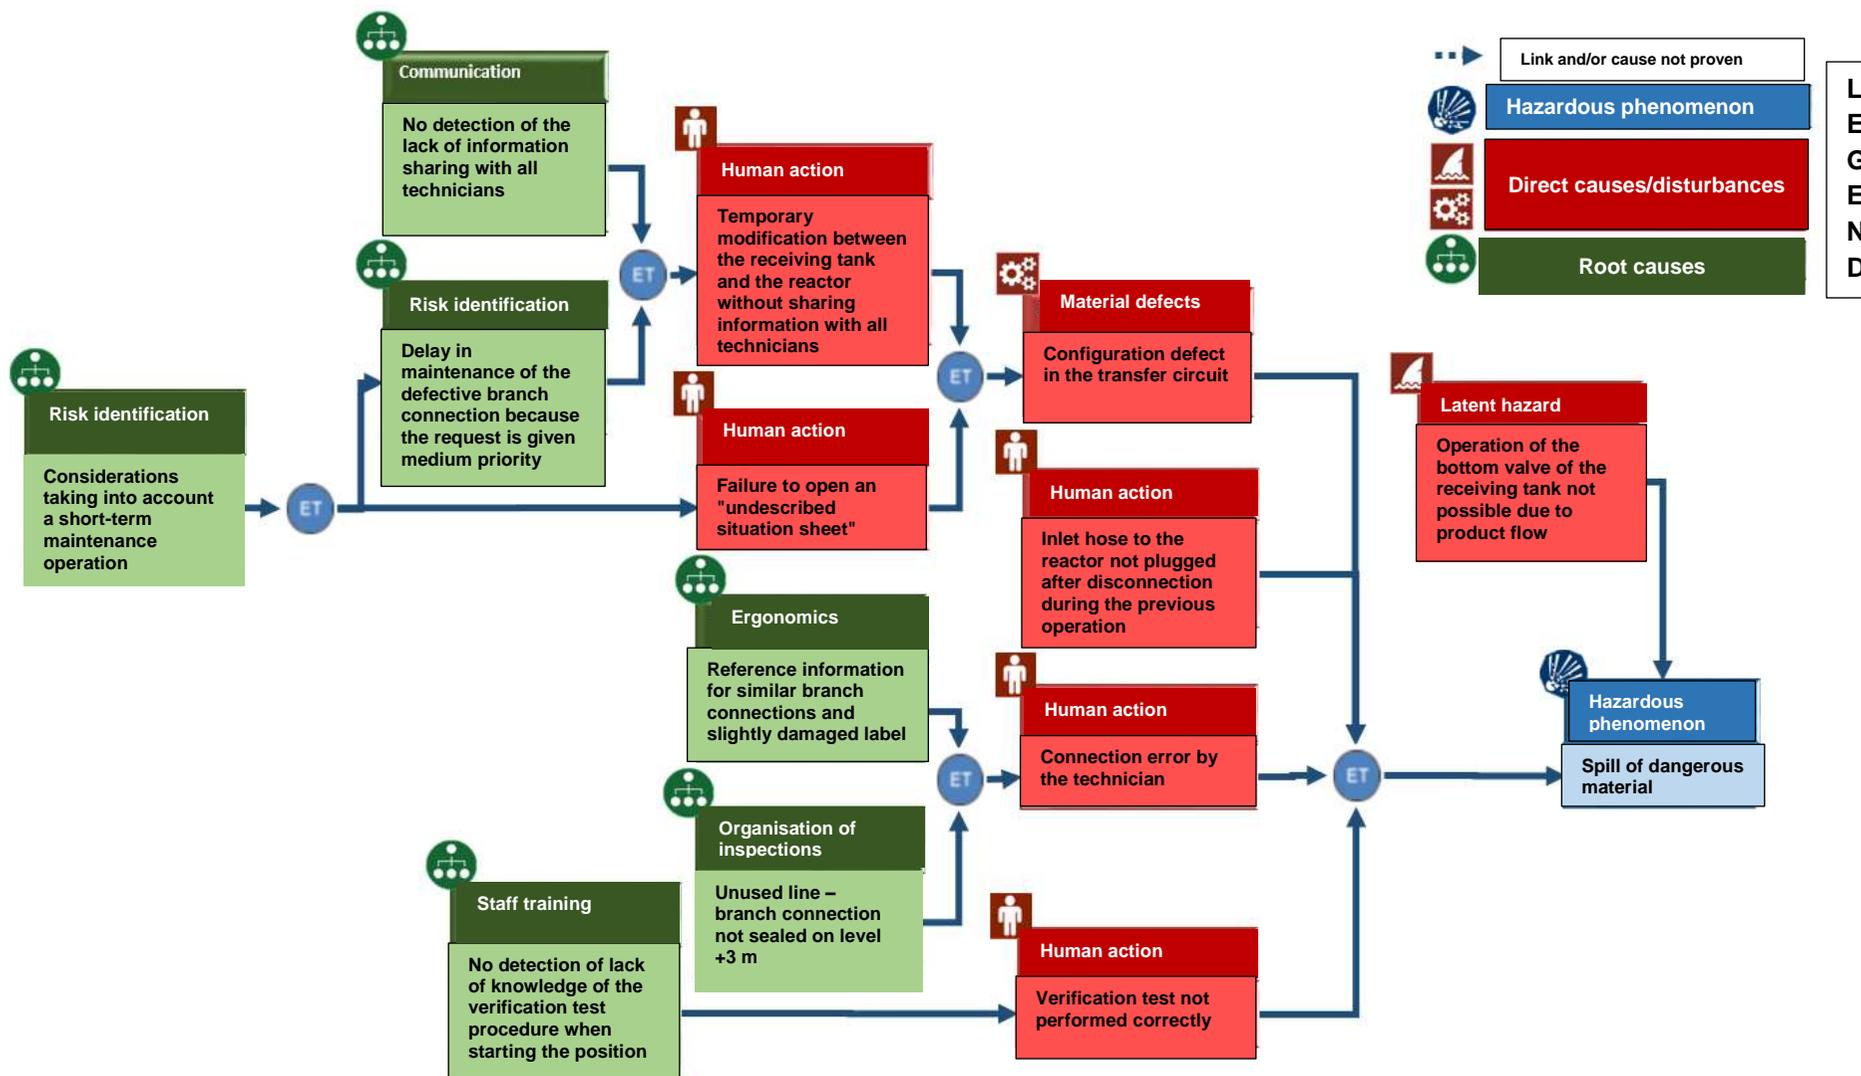
Finally, at the end of the installation of the circuit, the technician performed a pressure test to check tightness before any product transfer. However, this test did not comply with the standards recommended for this workshop and did not make it possible to detect leaks in the line. The technician analysed the results and found that the installation was compliant although it was not. Similarly, without this error, the technician could have detected the unusual configuration.

The technician had been working in this workshop for about one year. The technician previously worked in another workshop on the site where this type of test is mainly performed automatically and seldom manually. The technician was trained by coaching in this new workshop, without formal assessment of the ability to perform pressure tests. This lack of knowledge of the "pressure test" procedure was not known when starting the new position.
